Access Compliance Report

Public Rights-of-Way

(Curb Ramps)

Intersection ID: 14576	Main Street: COMMONWEALTH_AV	Cross Street: PINECREST_AV	Location: NW
ADA ID: DB2C6C8EC54F	Ramp Type: Perp	Initial Pass/Fail: Fail	Overall Compliance: No
			Severity Score: 31.25

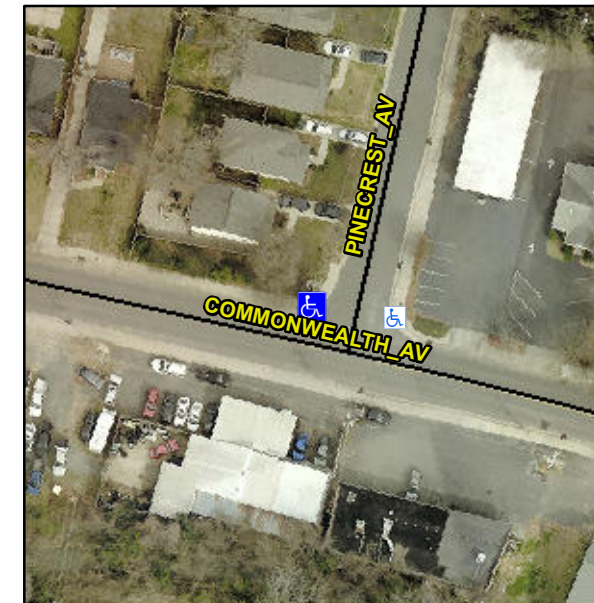
Not Found, R304.5.1, R304.2.2, R304.5.3

Compliance	Description	Data	Compliance	Description	Data
N/A	Ramp Length (in)	59.0	No	Ramp Slope (%)	9.0
No	Ramp Width (in)	35.0	No	Ramp XSlope (%)	2.3
N/A	Flare Type LT	N/A	N/A	Flare Type RT	N/A
N/A	Flare Slope LT (%)	N/A	N/A	Flare Slope RT (%)	N/A
N/A	Flare Traversable LT?	N/A	N/A	Flare Traversable RT?	N/A
N/A	Landing Length (in)	N/A	N/A	DWS Provided?	N/A
N/A	Landing Width (in)	N/A	N/A	DWS Contrast?	N/A
N/A	Landing Slope (%)	N/A	N/A	DWS Length (in)	N/A
N/A	Landing X Slope (%)	N/A	N/A	DWS Full Width?	N/A
N/A	Landing Curb? (Y/N)	N/A	N/A	DWS Offset (in)	N/A
N/A	Shared Landing?	N/A			
N/A	Gutter Ponding?	Yes	N/A	Gutter Slope (%)	N/A
N/A	Gutter Lip Ht (in)	N/A	N/A	Gutter X Slope (%)	N/A
N/A	Painted X Walk1?	No	N/A	Painted X Walk2?	N/A
	X Walk 1 Direction	To E		X Walk 2 Direction	N/A
N/A	X Walk 1 Width (in)	N/A	N/A	X Walk 2 Width (in)	N/A
	X Walk 1 Slope (%)	2.7		X Walk 2 Slope (%)	N/A
	X Walk 1 X Slope (%)	0.5		X Walk 2 X Slope (%)	N/A

Remove & Replace Entire Ramp.
