Access Compliance Report Public Rights-of-Way (Curb Ramps)

Intersection ID: 29706 Main Street: SIMFIELD CHURCH RD **Cross Street: WEDDINGTON RIDGE LN** Location: **ADA ID: DB2ECD4EF358** Ramp Type: Perp Initial Pass/Fail: Fail **Overall Compliance: No** Severity Score: 21.25

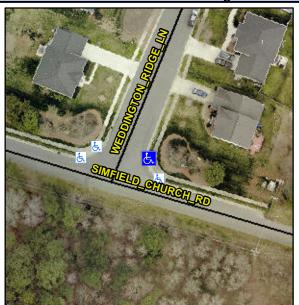
Field Measurements/Component Compliance					
Compliance Description Dat		Data	Comp	liance Description	Data
N/A	Ramp Length (in)	49.5	No	Ramp Slope (%)	10.5
No	Ramp Width (in)	36.5	Yes	Ramp XSlope (%)	0.1
N/A	Flare Type LT	N/A	N/A	Flare Type RT	N/A
N/A	Flare Slope LT (%)	N/A	N/A	Flare Slope RT (%)	N/A
N/A	Flare Traversable LT?	N/A	N/A	Flare Traversable RT?	N/A
N/A	Landing Length (in)	N/A	N/A	DWS Provided?	N/A
N/A	Landing Width (in)	N/A	N/A	DWS Contrast?	N/A
N/A	Landing Slope (%)	N/A	N/A	DWS Length (in)	N/A
N/A	Landing X Slope (%)	N/A	N/A	DWS Full Width?	N/A
N/A	Landing Curb? (Y/N)	N/A	N/A	DWS Offset (in)	N/A
N/A	Shared Landing?	N/A			
N/A	Gutter Ponding?	N/A	N/A	Gutter Slope (%)	N/A
N/A	Gutter Lip Ht (in)	N/A	N/A	Gutter X Slope (%)	N/A
N/A	Painted X Walk1?	No	N/A	Painted X Walk2?	N/A
	X Walk 1 Direction	To NE		X Walk 2 Direction	N/A
N/A	X Walk 1 Width (in)	N/A	N/A	X Walk 2 Width (in)	N/A
	X Walk 1 Slope (%)	4.2		X Walk 2 Slope (%)	N/A

X Walk 1 X Slope (%)	1.4		X Walk 2 X Slope (%)	N/A
N/A	Ramp inside XWalk1?	N/A	N/A	Ramp inside XWalk2?	N/A
	Road Slope (%)	N/A	N/A	Clear Space?	N/A
	Road X Slope (%)	N/A	N/A	Clear Space to XWalk (in)	N/A
N/A	Any Obstructions?	N/A	N/A	Storm Grate/Utility Hazard?	N/A
	Obstruction Type			Storm Grate/Utility Type	
		N/A			N/A
			Yes	Surface Condition? (G/P)	Good
	The second second

Possible Solutions: Remove & Replace Entire Ramp. Surveyor Notes: N/A PROW/ADA: Not Found, R304.5.1, R304.2.2
