Access Compliance Report

Public Rights-of-Way

(Curb Ramps)

Intersection ID: 3210	Main Street: NOTTINGHILL_LN	Cross Street: CARVER_POND_RD	Location: SW
ADA ID: DB3402F9EA63	Ramp Type: PerpDiag	Initial Pass/Fail: Fail	Overall Compliance: No
		Severity Score: 42.5

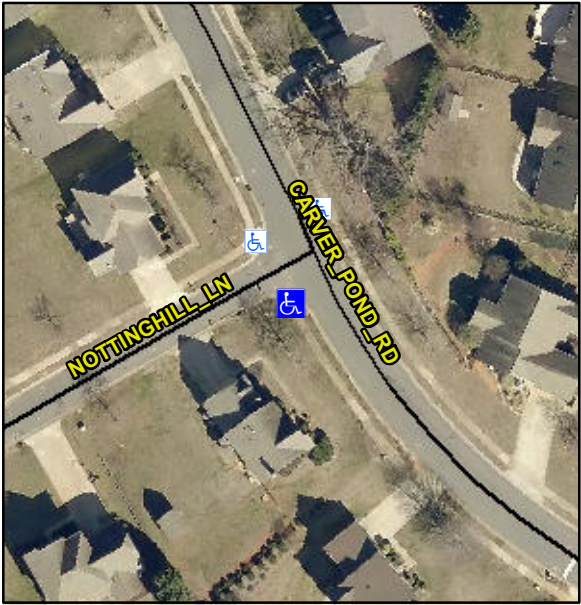
Possible Solutions:		Compliance	Description	Data
	Remove & Replace Curb Ramp With Two New Directional Ramps or Equivalent.		N/A	Ramp Length (in)	96.0
			No	Ramp Width (in)	33.0
			N/A	Flare Type LT	N/A
			N/A	Flare Slope LT (%)	N/A
			N/A	Flare Traversable LT?	N/A
			N/A	Landing Length (in)	N/A
			N/A	Landing Width (in)	N/A
			N/A	Landing Slope (%)	N/A
			N/A	Landing X Slope (%)	N/A
<p>Surveyor Notes:</p> <p>N/A</p> <p>PROW/ADA:</p> <p>R304.5.1, R304.2.2</p>			N/A	Flare Type RT	N/A
			N/A	Flare Slope RT (%)	N/A
			N/A	Flare Traversable RT?	N/A
			N/A	DWS Provided?	N/A
			N/A	DWS Contrast?	N/A
			N/A	DWS Length (in)	N/A
			N/A	DWS Full Width?	N/A
			N/A	DWS Offset (in)	N/A
			N/A	Gutter Ponding?	N/A
			N/A	Gutter Lip Ht (in)	N/A
<p>Total Cost:</p> <p>\$ 3200.00</p>			No	Painted X Walk1?	No
				X Walk 1 Direction	To E
			N/A	X Walk 1 Width (in)	N/A

X Walk 1 Slope (%)	2.8
				X Walk 1 X Slope (%)	1.6
			N/A	Ramp inside XWalk1?	N/A
				Road Slope (%)	2.4
				Road X Slope (%)	0.9
			N/A	Any Obstructions?	N/A
				Obstruction Type	
			N/A	Clear Space?	N/A
			N/A	Clear Space to XWalk (in)	N/A
			N/A	Storm Grate/Utility Hazard?	N/A
				Storm Grate/Utility Type	
			N/A		N/A
			Yes	Surface Condition? (G/P)	Good
