# Access Compliance Report

## Public Rights-of-Way

### (Curb Ramps)

Intersection ID: 12638	Main Street: KENSINGTON_DR	Cross Street: THOMAS_AV	Location: NE
ADA ID: DB3903E80FEB	Ramp Type: Directional1	Initial Pass/Fail: Fail	Overall Compliance: No
Codes/Mitigation Info/Possible Solution		Field Measurements/Component Compliance	
Severity Score: 21.25

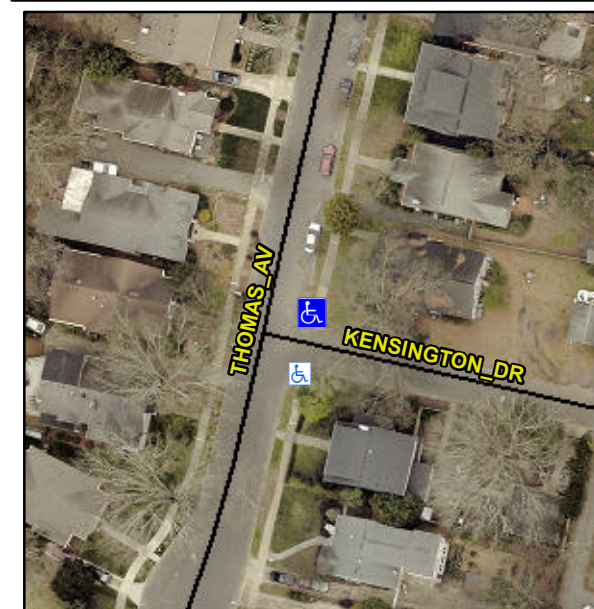
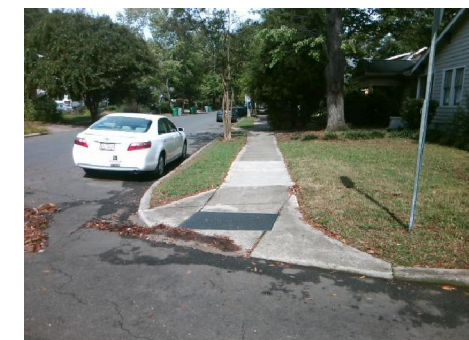
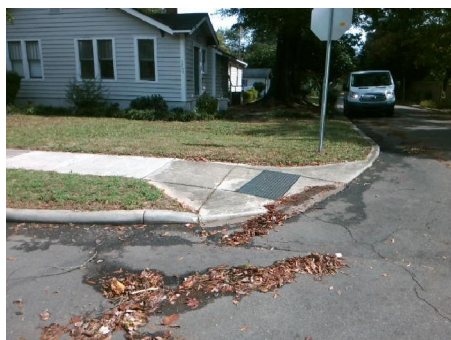
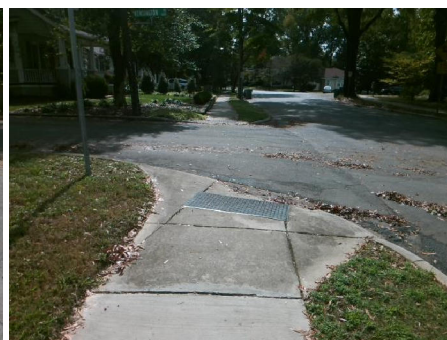
Compliance	Description	Data	Compliance	Description	Data
N/A	Ramp Length (in)	55.0	N/A	Grade Break?	N/A
No	Ramp Width (in)	46.0	N/A	Grade Break Slope (%)	0.0
Yes	Ramp Slope (%)	5.5	N/A	Grade Break XSlope (%)	0.0
No	Ramp XSlope (%)	6.6			
N/A	Flare Type LT	N/A	N/A	Flare Type RT	N/A
N/A	Flare Slope LT (%)	N/A	N/A	Flare Slope RT (%)	0.0
N/A	Flare Traversable LT?	N/A	N/A	Flare Traversable RT?	N/A
N/A	Landing Length (in)	0.0	N/A	DWS Provided?	N/A
N/A	Landing Width (in)	0.0	N/A	DWS Contrast?	N/A
N/A	Landing Slope (%)	0.0	N/A	DWS Length (in)	N/A
N/A	Landing X Slope (%)	0.0	N/A	DWS Full Width?	N/A
N/A	Landing Curb? (Y/N)	N/A	N/A	DWS Offset LT (in)	N/A
N/A	Shared Landing?	N/A	N/A	DWS Offset RT (in)	N/A
N/A	Gutter Ponding?	0.0	N/A	Gutter Slope (%)	N/A
N/A	Gutter Lip Ht (in)	0.0	N/A	Gutter X Slope (%)	N/A
N/A	Painted X Walk1?	No		Road Slope (%)	3.8
	X Walk 1 Direction	To S		Road X Slope (%)	4.6
	X Walk 1 Width (in)	N/A		Clear Space?	N/A

X Walk 1 Slope (%)	3.8	N/A	Clear Space to XWalk (in)	N/A
	X Walk 1 X Slope (%)	4.6	N/A	Storm Grate/Utility Hazard?	N/A
N/A	Ramp inside XWalk1?	N/A		Storm Grate/Utility Type	
N/A	Any Obstructions?	N/A			N/A
	Obstruction Type		Yes	Surface Condition? (G/P)	Good
			N/A	Curb Slope (%)	0.1

**Remove & Replace Entire Ramp.**

**R304.5.1, R304.5.3**

**\$ 1600.00**
