Intersection ID: 22470	Main Street: SHARON_VIEW_RD	Cross Street: BENTRIDGE_DR	Location:	NE
ADA ID: DB3FA3F6AF7E	Ramp Type: PerpDiag	Initial Pass/Fail: Fail	Overall Compliance: No	Severity Score: 13.75

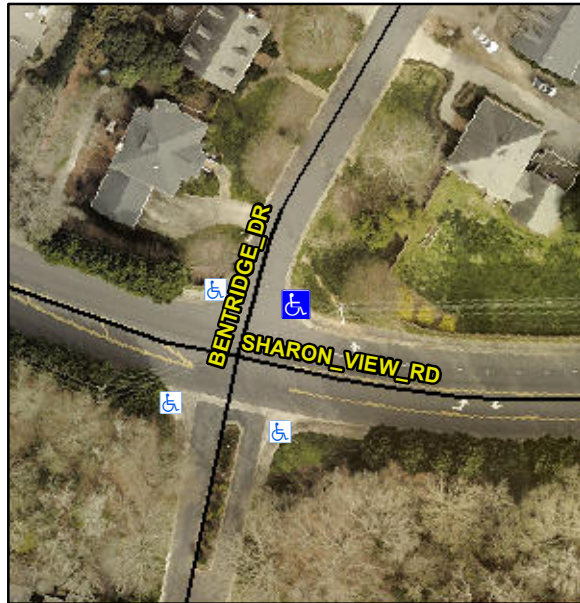
Not Found, R304.2.2, R304.5.3

Compliance	Description	Data	Compliance	Description	Data
N/A	Ramp Length (in)	60.0	No	Ramp Slope (%)	10.6
Yes	Ramp Width (in)	48.0	No	Ramp XSlope (%)	2.9
N/A	Flare Type LT	N/A	N/A	Flare Type RT	N/A
N/A	Flare Slope LT (%)	N/A	N/A	Flare Slope RT (%)	N/A
N/A	Flare Traversable LT?	N/A	N/A	Flare Traversable RT?	N/A
N/A	Landing Length (in)	N/A	N/A	DWS Provided?	N/A
N/A	Landing Width (in)	N/A	N/A	DWS Contrast?	N/A
N/A	Landing Slope (%)	N/A	N/A	DWS Length (in)	N/A
N/A	Landing X Slope (%)	N/A	N/A	DWS Full Width?	N/A
N/A	Landing Curb? (Y/N)	N/A	N/A	DWS Offset (in)	N/A
N/A	Shared Landing?	N/A			
N/A	Gutter Ponding?	N/A	N/A	Gutter Slope (%)	N/A
N/A	Gutter Lip Ht (in)	N/A	N/A	Gutter X Slope (%)	N/A
N/A	Painted X Walk1?	No	N/A	Painted X Walk2?	No
	X Walk 1 Direction	To NW		X Walk 2 Direction	To SW
N/A	X Walk 1 Width (in)	N/A	N/A	X Walk 2 Width (in)	N/A
	X Walk 1 Slope (%)	9.6		X Walk 2 Slope (%)	4.8
	X Walk 1 X Slope (%)	5.3		X Walk 2 X Slope (%)	6.5

N/A	Ramp inside XWalk1?	N/A	N/A	Ramp inside XWalk2?	N/A
	Road Slope (%)	1.7	N/A	Clear Space?	N/A
	Road X Slope (%)	10.4	N/A	Clear Space to XWalk (in)	N/A
N/A	Any Obstructions?	N/A	N/A	Storm Grate/Utility Hazard?	N/A
	Obstruction Type			Storm Grate/Utility Type	
		N/A			N/A
			Yes	Surface Condition? (G/P)	Good

Remove & Replace Curb Ramp With Two New Directional Ramps or Equivalent.

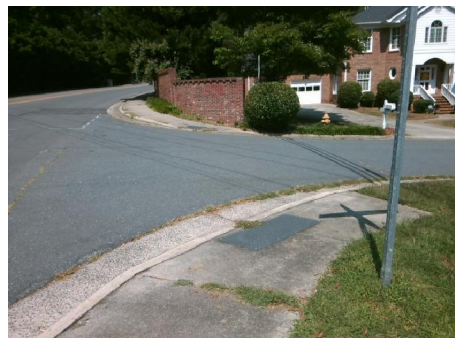
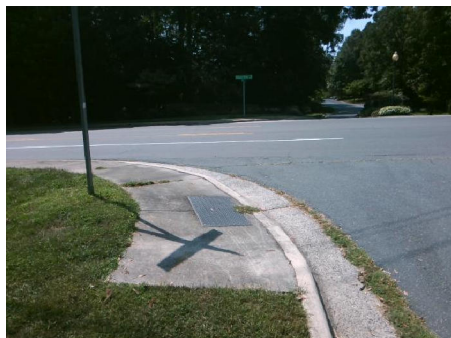
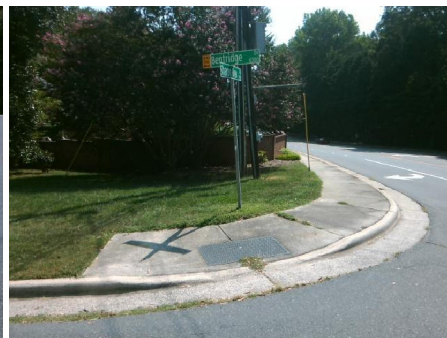
Street 1 Name	BENTRIDGE DR
Stop Condition-Street 2	StopSign
Street 2 Name	SHARON VIEW RD
Stop Condition-Street 1	None
