Access Compliance Report

Public Rights-of-Way

(Curb Ramps)

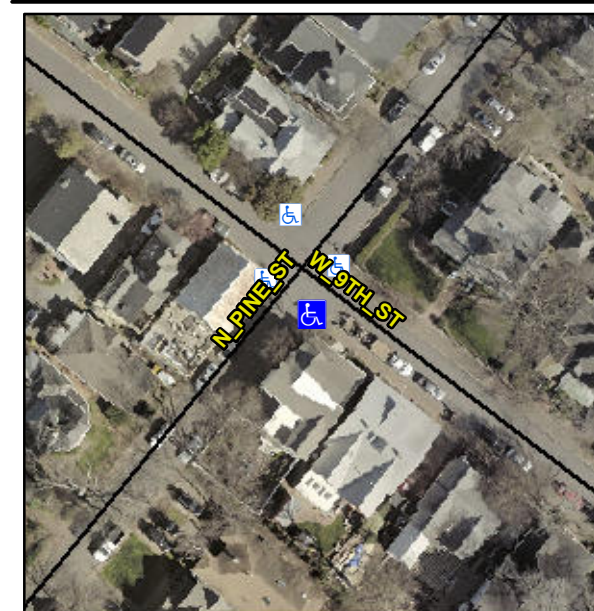
Intersection ID: 11541	Main Street: W_9TH_ST	Cross Street: N_PINE_ST	Location: S
ADA ID: DB470D4EDF94	Ramp Type: PerpDiag	Initial Pass/Fail: Fail	Overall Compliance: No
Severity Score: 46.25			
Codes/Mitigation Info/Possible Solution		Field Measurements/Component Compliance

Not Found, R304.5.1, R304.2.2, R304.5.3

Compliance	Description	Data	Compliance	Description	Data
N/A	Ramp Length (in)	39.0	No	Ramp Slope (%)	10.2
No	Ramp Width (in)	43.0	No	Ramp XSlope (%)	11.2
N/A	Flare Type LT	N/A	N/A	Flare Type RT	N/A
N/A	Flare Slope LT (%)	N/A	N/A	Flare Slope RT (%)	N/A
N/A	Flare Traversable LT?	N/A	N/A	Flare Traversable RT?	N/A
N/A	Landing Length (in)	N/A	N/A	DWS Provided?	N/A
N/A	Landing Width (in)	N/A	N/A	DWS Contrast?	N/A
N/A	Landing Slope (%)	N/A	N/A	DWS Length (in)	N/A
N/A	Landing X Slope (%)	N/A	N/A	DWS Full Width?	N/A
N/A	Landing Curb? (Y/N)	N/A	N/A	DWS Offset (in)	N/A
N/A	Shared Landing?	N/A			
N/A	Gutter Ponding?	N/A	N/A	Gutter Slope (%)	N/A
N/A	Gutter Lip Ht (in)	N/A	N/A	Gutter X Slope (%)	N/A
N/A	Painted X Walk1?	No	N/A	Painted X Walk2?	No
	X Walk 1 Direction	To NE		X Walk 2 Direction	To NW
N/A	X Walk 1 Width (in)	N/A	N/A	X Walk 2 Width (in)	N/A
	X Walk 1 Slope (%)	6.4		X Walk 2 Slope (%)	2.2
	X Walk 1 X Slope (%)	1.3		X Walk 2 X Slope (%)	3.8

N/A	Ramp inside XWalk1?	N/A	N/A	Ramp inside XWalk2?	N/A
	Road Slope (%)	5.5	N/A	Clear Space?	N/A
	Road X Slope (%)	6.5	N/A	Clear Space to XWalk (in)	N/A
N/A	Any Obstructions?	N/A	N/A	Storm Grate/Utility Hazard?	N/A
	Obstruction Type			Storm Grate/Utility Type	
		N/A			N/A
			Yes	Surface Condition? (G/P)	Good

Remove & Replace Curb Ramp With Two New Directional Ramps or Equivalent.
