Access Compliance Report

Public Rights-of-Way

(Curb Ramps)

Intersection ID: 15160	Main Street: GRIFFITH_ST	Cross Street: S_TRYON_ST	Location: SE
ADA ID: DB47A7CF3602	Ramp Type: Perp	Initial Pass/Fail: Fail	Overall Compliance: No
Severity Score: 22.5			
Codes/Mitigation Info/Possible Solution		Field Measurements/Component Compliance

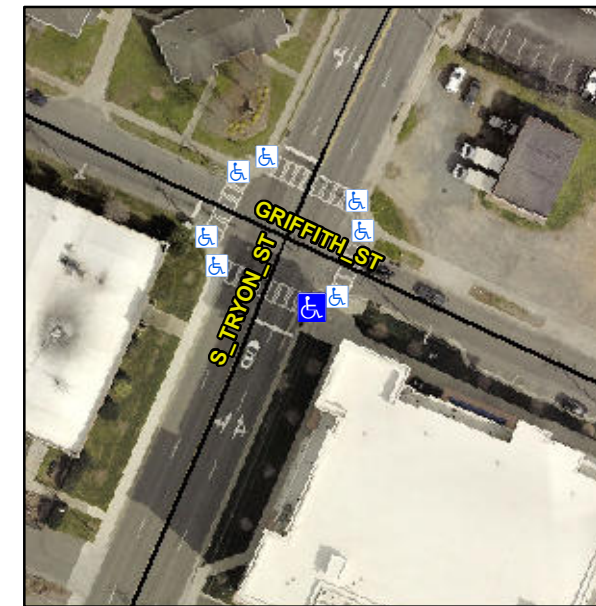
Not Found, R304.5.1, R304.2.2, R304.5.3

Compliance	Description	Data	Compliance	Description	Data
N/A	Ramp Length (in)	108.0	No	Ramp Slope (%)	8.6
No	Ramp Width (in)	46.0	No	Ramp XSlope (%)	3.8
N/A	Flare Type LT	N/A	N/A	Flare Type RT	N/A
N/A	Flare Slope LT (%)	N/A	N/A	Flare Slope RT (%)	N/A
N/A	Flare Traversable LT?	N/A	N/A	Flare Traversable RT?	N/A
N/A	Landing Length (in)	N/A	N/A	DWS Provided?	N/A
N/A	Landing Width (in)	N/A	N/A	DWS Contrast?	N/A
N/A	Landing Slope (%)	N/A	N/A	DWS Length (in)	N/A
N/A	Landing X Slope (%)	N/A	N/A	DWS Full Width?	N/A
N/A	Landing Curb? (Y/N)	N/A	N/A	DWS Offset (in)	N/A
N/A	Shared Landing?	N/A			
N/A	Gutter Ponding?	N/A	N/A	Gutter Slope (%)	N/A
N/A	Gutter Lip Ht (in)	N/A	N/A	Gutter X Slope (%)	N/A
N/A	Painted X Walk1?	Yes	N/A	Painted X Walk2?	N/A
	X Walk 1 Direction	To NW		X Walk 2 Direction	N/A
N/A	X Walk 1 Width (in)	117.0	N/A	X Walk 2 Width (in)	N/A
	X Walk 1 Slope (%)	1.2		X Walk 2 Slope (%)	N/A
	X Walk 1 X Slope (%)	2.3		X Walk 2 X Slope (%)	N/A

N/A	Ramp inside XWalk1?	Yes	N/A	Ramp inside XWalk2?	N/A
	Road Slope (%)	N/A	N/A	Clear Space?	N/A
	Road X Slope (%)	N/A	N/A	Clear Space to XWalk (in)	N/A
N/A	Any Obstructions?	N/A	N/A	Storm Grate/Utility Hazard?	N/A
	Obstruction Type			Storm Grate/Utility Type	
		N/A			N/A
		Yes		Surface Condition? (G/P)	Good

Possible Solutions:

Remove & Replace Entire Ramp.
