# Access Compliance Report

## Public Rights-of-Way

### (Curb Ramps)

| Intersection ID: 6096 | Main Street: BURMITH_AV | Cross Street: STATESVILLE_RD | Location: SW |

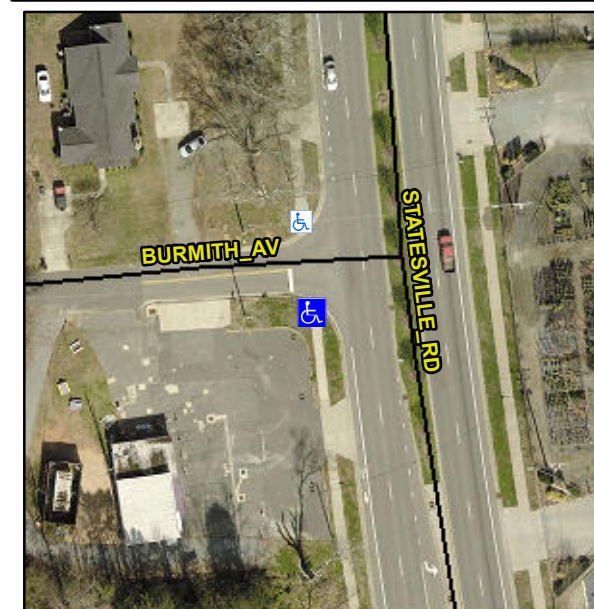
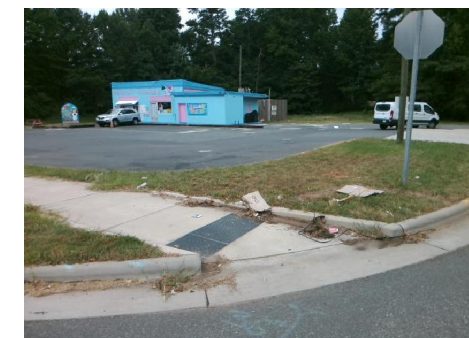
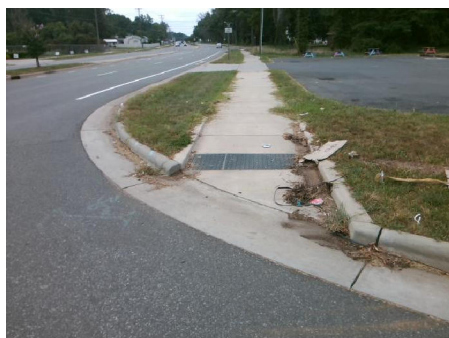
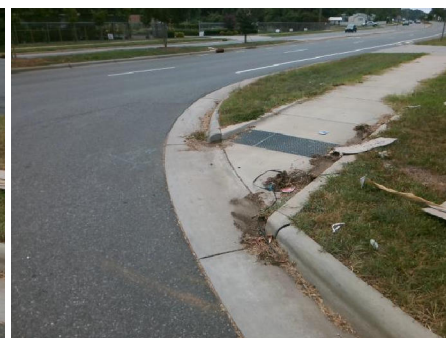
| ADA ID: DB55CF70A7E3 | Ramp Type: Directional1 | Initial Pass/Fail: Pass | Overall Compliance: No |
| Severity Score: 7.5 | | | |

**Not Found, R304.5.3, R302.7, R302.7.2**

| Compliance | Description | Data | Compliance | Description | Data |
|---|---|---|---|---|---|
| Yes | Ramp Slope (%) | 5.5 | No | Grade Break XSlope (%) | 3.4 |
| No | Gutter Ponding? | Yes | Yes | Gutter Slope (%) | 2.5 |
| No | Gutter Lip Ht (in) | 0.3 | Yes | Gutter X Slope (%) | 0.1 |

**Remove & Replace Entire Ramp.**
