# Access Compliance Report

## Public Rights-of-Way

### (Curb Ramps)

Intersection ID: 17028	Main Street: MEADOWDALE_LN	Cross Street: MISSION_HILLS_RD	Location: NW
ADA ID: DB64D722A426	Ramp Type: PerpDiag	Initial Pass/Fail: Fail	Overall Compliance: No
			Severity Score: 13.75

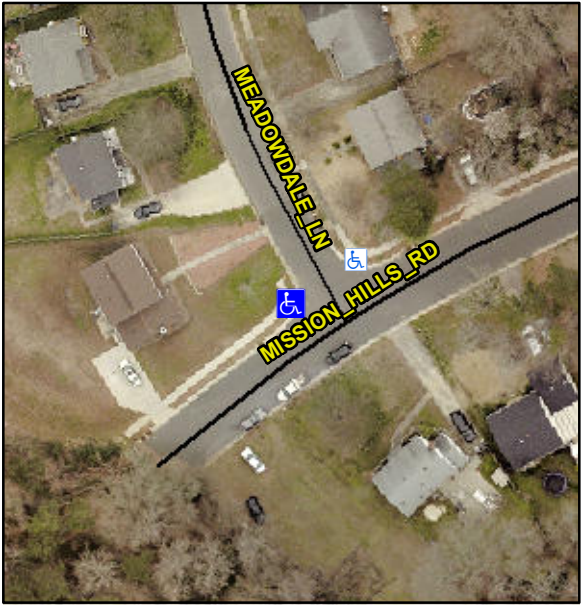
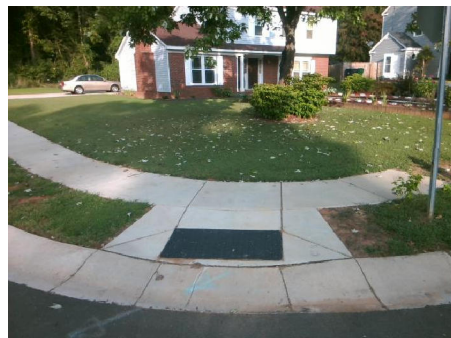
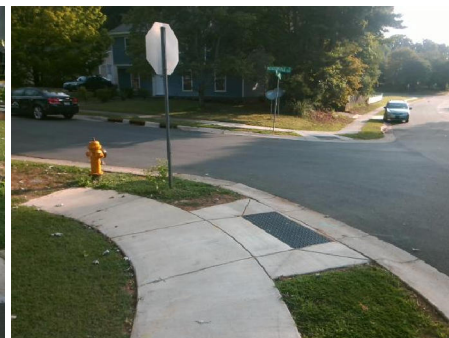
Possible Solutions:		<b>Compliance</b>	<b>Description</b>	<b>Data</b>
	<b>Remove &amp; Replace Curb Ramp With Two New Directional Ramps or Equivalent.</b>		<b>No</b>	Ramp Length (in)	<b>48.0</b>
			<b>Yes</b>	Ramp Width (in)	<b>48.0</b>
			<b>N/A</b>	Flare Type LT	<b>N/A</b>
			<b>N/A</b>	Flare Slope LT (%)	<b>N/A</b>
			<b>N/A</b>	Flare Traversable LT?	<b>N/A</b>
			<b>N/A</b>	Landing Length (in)	<b>N/A</b>
			<b>N/A</b>	Landing Width (in)	<b>N/A</b>
			<b>N/A</b>	Landing Slope (%)	<b>N/A</b>
			<b>N/A</b>	Landing X Slope (%)	<b>N/A</b>
<p>Surveyor Notes:</p> <p><b>N/A</b></p> <p>PROW/ADA:</p> <p><b>Not Found, R304.2.2, R304.5.3</b></p>			<b>N/A</b>	Flare Type RT	<b>N/A</b>
			<b>N/A</b>	Flare Slope RT (%)	<b>N/A</b>
			<b>N/A</b>	Flare Traversable RT?	<b>N/A</b>
			<b>N/A</b>	DWS Provided?	<b>N/A</b>
			<b>N/A</b>	DWS Contrast?	<b>N/A</b>

<b>N/A</b>	DWS Length (in)	<b>N/A</b>
			<b>N/A</b>	DWS Full Width?	<b>N/A</b>
			<b>N/A</b>	DWS Offset (in)	<b>N/A</b>
			<b>N/A</b>	Gutter Ponding?	<b>N/A</b>
			<b>N/A</b>	Gutter Lip Ht (in)	<b>N/A</b>
			<b>No</b>	Painted X Walk1?	<b>No</b>
				X Walk 1 Direction	<b>To SE</b>
			<b>N/A</b>	X Walk 1 Width (in)	<b>N/A</b>
			<b>1.5</b>	X Walk 1 Slope (%)	<b>0.9</b>
			<b>2.4</b>	X Walk 1 X Slope (%)	<b>2.1</b>
			<b>N/A</b>	Ramp inside XWalk1?	<b>N/A</b>
			<b>0.4</b>	Road Slope (%)	<b>N/A</b>
			<b>2.5</b>	Road X Slope (%)	<b>N/A</b>
			<b>N/A</b>	Any Obstructions?	<b>N/A</b>
				Obstruction Type	
Total Cost:			<b>\$</b>	<b>3200.00</b>	
			<b>N/A</b>		<b>N/A</b>
			<b>Yes</b>	Surface Condition? (G/P)	<b>Good</b>
