Access Compliance Report

Public Rights-of-Way

(Curb Ramps)

Intersection ID: 12011	Main Street: E_16TH_ST	Cross Street: HARRILL_ST	Location: W
ADA ID: DB67BE8796A8	Ramp Type: PerpDiag	Initial Pass/Fail: Fail	Overall Compliance: No
			Severity Score: 18.75

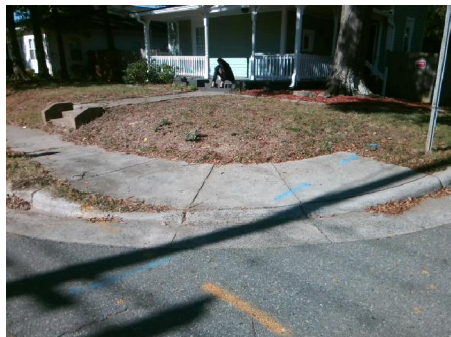
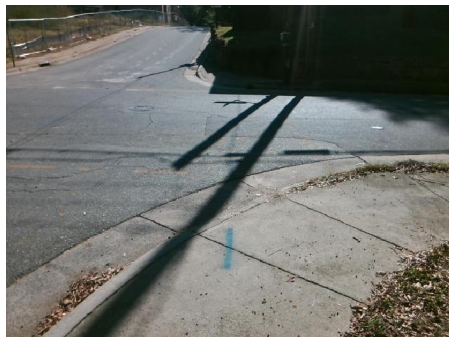
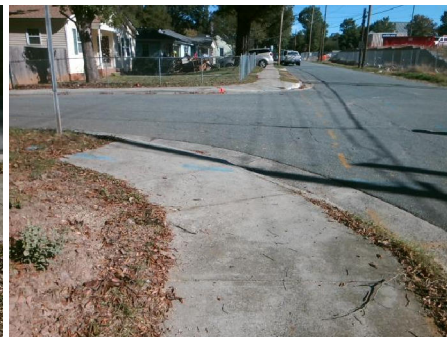
Not Found, R304.5.1, R304.5.3

Compliance	Description	Data	Compliance	Description	Data
N/A	Ramp Length (in)	60.0	Yes	Ramp Slope (%)	5.5
No	Ramp Width (in)	33.0	No	Ramp XSlope (%)	2.9
N/A	Flare Type LT	N/A	N/A	Flare Type RT	N/A
N/A	Flare Slope LT (%)	N/A	N/A	Flare Slope RT (%)	N/A
N/A	Flare Traversable LT?	N/A	N/A	Flare Traversable RT?	N/A
N/A	Landing Length (in)	N/A	N/A	DWS Provided?	N/A
N/A	Landing Width (in)	N/A	N/A	DWS Contrast?	N/A
N/A	Landing Slope (%)	N/A	N/A	DWS Length (in)	N/A
N/A	Landing X Slope (%)	N/A	N/A	DWS Full Width?	N/A
N/A	Landing Curb? (Y/N)	N/A	N/A	DWS Offset (in)	N/A
N/A	Shared Landing?	N/A			
N/A	Gutter Ponding?	N/A	N/A	Gutter Slope (%)	N/A
N/A	Gutter Lip Ht (in)	N/A	N/A	Gutter X Slope (%)	N/A
N/A	Painted X Walk1?	No	N/A	Painted X Walk2?	No
	X Walk 1 Direction	To SE		X Walk 2 Direction	To NE
N/A	X Walk 1 Width (in)	N/A	N/A	X Walk 2 Width (in)	N/A
	X Walk 1 Slope (%)	0.4		X Walk 2 Slope (%)	4.1
	X Walk 1 X Slope (%)	4.3		X Walk 2 X Slope (%)	0.7

N/A	Ramp inside XWalk1?	N/A	N/A	Ramp inside XWalk2?	N/A
	Road Slope (%)	0.3	N/A	Clear Space?	N/A
	Road X Slope (%)	4.4	N/A	Clear Space to XWalk (in)	N/A
N/A	Any Obstructions?	N/A	N/A	Storm Grate/Utility Hazard?	N/A
	Obstruction Type			Storm Grate/Utility Type	
		N/A			N/A
			Yes	Surface Condition? (G/P)	Good

Remove & Replace Curb Ramp With Two New Directional Ramps or Equivalent.
