Access Compliance Report

Public Rights-of-Way

(Curb Ramps)

Intersection ID: 16008	Main Street: SEDGEFIELD_RD	Cross Street: WRISTON_PL	Location: NE
ADA ID: DB813AE7EA97	Ramp Type: Directional1	Initial Pass/Fail: Fail	Overall Compliance: No
			Severity Score: 13.75

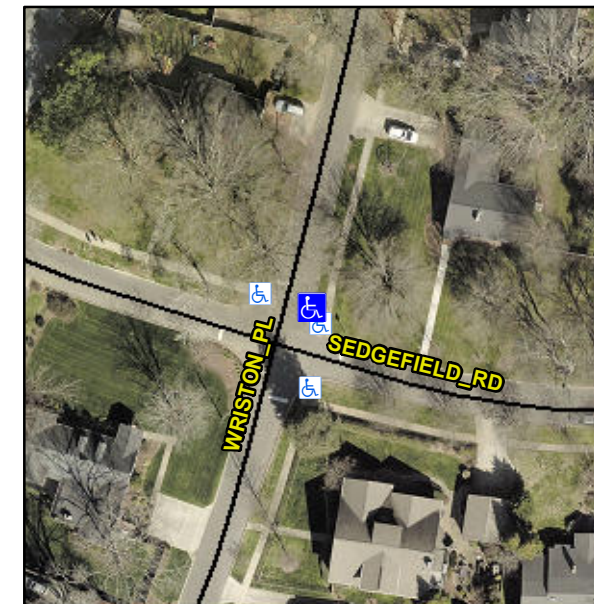
LNDG GAP 1.0"

R304.2.2, R304.5.3

Compliance	Description	Data	Compliance	Description	Data
N/A	Ramp Length (in)	59.0	N/A	Grade Break?	N/A
Yes	Ramp Width (in)	56.0	N/A	Grade Break Slope (%)	0.0
No	Ramp Slope (%)	9.3	N/A	Grade Break XSlope (%)	0.0
No	Ramp XSlope (%)	3.5			
N/A	Flare Type LT	N/A	N/A	Flare Type RT	N/A
N/A	Flare Slope LT (%)	N/A	N/A	Flare Slope RT (%)	0.0
N/A	Flare Traversable LT?	N/A	N/A	Flare Traversable RT?	N/A
N/A	Landing Length (in)	0.0	N/A	DWS Provided?	N/A
N/A	Landing Width (in)	0.0	N/A	DWS Contrast?	N/A
N/A	Landing Slope (%)	0.0	N/A	DWS Length (in)	N/A
N/A	Landing X Slope (%)	0.0	N/A	DWS Full Width?	N/A
N/A	Landing Curb? (Y/N)	N/A	N/A	DWS Offset LT (in)	N/A
N/A	Shared Landing?	N/A	N/A	DWS Offset RT (in)	N/A
N/A	Gutter Ponding?	0.0	N/A	Gutter Slope (%)	N/A
N/A	Gutter Lip Ht (in)	0.0	N/A	Gutter X Slope (%)	N/A
N/A	Painted X Walk1?	No		Road Slope (%)	4.8
	X Walk 1 Direction	To W		Road X Slope (%)	2.3
	X Walk 1 Width (in)	N/A		Clear Space?	N/A

X Walk 1 Slope (%)	4.8	N/A	Clear Space to XWalk (in)	N/A
	X Walk 1 X Slope (%)	2.3	N/A	Storm Grate/Utility Hazard?	N/A
N/A	Ramp inside XWalk1?	N/A		Storm Grate/Utility Type	
N/A	Any Obstructions?	N/A			N/A
	Obstruction Type		Yes	Surface Condition? (G/P)	Good
			N/A	Curb Slope (%)	0.9

Remove & Replace Entire Ramp.
