Intersection ID: 47116	Main Street: MCKEE_FOREST_CT	Cross Street: CARPENTER_CABIN_DR	Location:	SW
ADA ID: DB893EAEAA44	Ramp Type: Perp	Initial Pass/Fail: Fail	Overall Compliance: No	Severity Score: 10

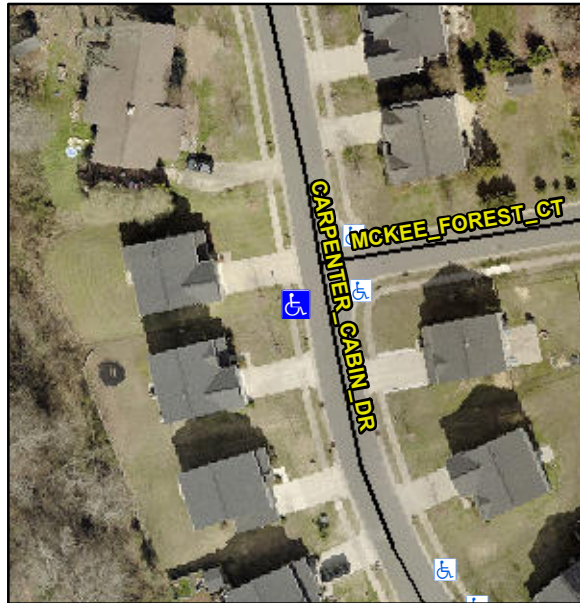
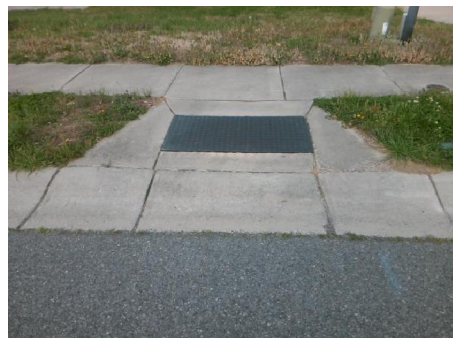
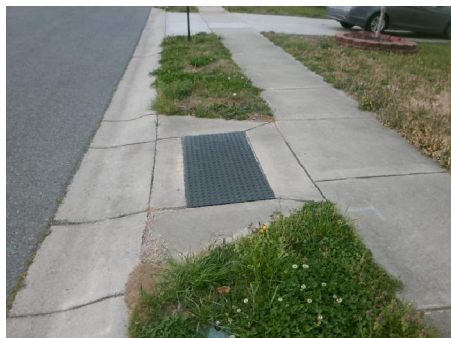
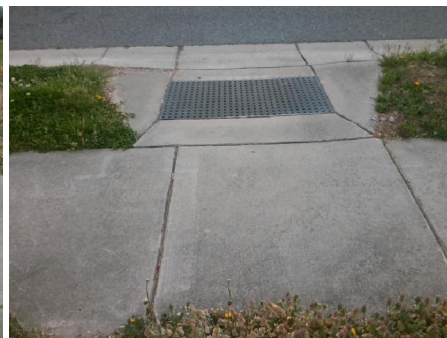
Not Found, R304.5.1, R304.5.3

Compliance	Description	Data	Compliance	Description	Data
N/A	Ramp Length (in)	48.0	Yes	Ramp Slope (%)	5.3
No	Ramp Width (in)	46.0	No	Ramp XSlope (%)	4.8
N/A	Flare Type LT	N/A	N/A	Flare Type RT	N/A
N/A	Flare Slope LT (%)	N/A	N/A	Flare Slope RT (%)	N/A
N/A	Flare Traversable LT?	N/A	N/A	Flare Traversable RT?	N/A
N/A	Landing Length (in)	N/A	N/A	DWS Provided?	N/A
N/A	Landing Width (in)	N/A	N/A	DWS Contrast?	N/A
N/A	Landing Slope (%)	N/A	N/A	DWS Length (in)	N/A
N/A	Landing X Slope (%)	N/A	N/A	DWS Full Width?	N/A
N/A	Landing Curb? (Y/N)	N/A	N/A	DWS Offset (in)	N/A
N/A	Shared Landing?	N/A			
N/A	Gutter Ponding?	N/A	N/A	Gutter Slope (%)	N/A
N/A	Gutter Lip Ht (in)	N/A	N/A	Gutter X Slope (%)	N/A
N/A	Painted X Walk1?	No	N/A	Painted X Walk2?	N/A
	X Walk 1 Direction	To E		X Walk 2 Direction	N/A
N/A	X Walk 1 Width (in)	N/A	N/A	X Walk 2 Width (in)	N/A
	X Walk 1 Slope (%)	4.8		X Walk 2 Slope (%)	N/A
	X Walk 1 X Slope (%)	3.1		X Walk 2 X Slope (%)	N/A

N/A	Ramp inside XWalk1?	N/A	N/A	Ramp inside XWalk2?	N/A
	Road Slope (%)	N/A	N/A	Clear Space?	N/A
	Road X Slope (%)	N/A	N/A	Clear Space to XWalk (in)	N/A
N/A	Any Obstructions?	N/A	N/A	Storm Grate/Utility Hazard?	N/A
	Obstruction Type			Storm Grate/Utility Type	
		N/A			N/A
			Yes	Surface Condition? (G/P)	Good

Remove & Replace Entire Ramp.

Total Cost: \$ 1850.00
