Access Compliance Report

Public Rights-of-Way

(Curb Ramps)

Intersection ID: 25142	Main Street: COTTON_CREEK_DR	Cross Street: WEAVER_MILL_LN	Location: S
ADA ID: DB8964A8481C	Ramp Type: PerpDiag	Initial Pass/Fail: Fail	Overall Compliance: No
Severity Score: 33.75			
Codes/Mitigation Info/Possible Solution		Field Measurements/Component Compliance

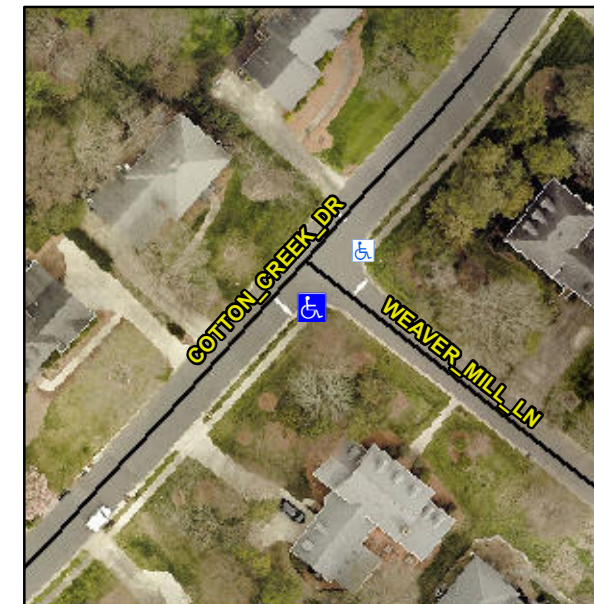
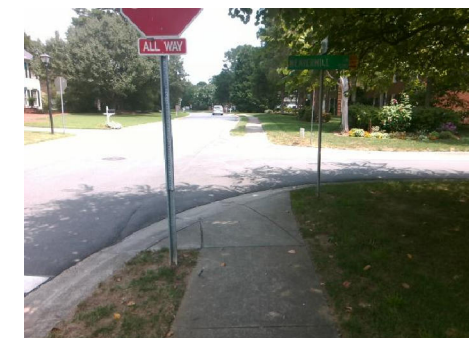
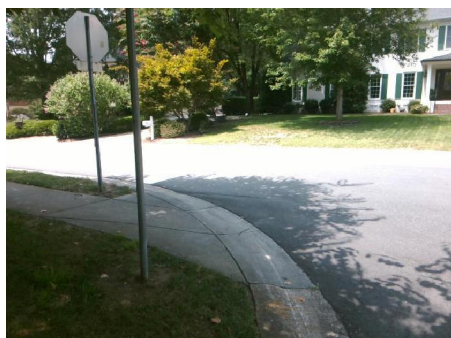
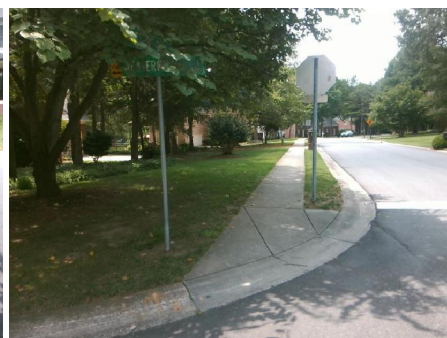
Not Found, R304.5.1, R304.2.2, R304.5.3

Compliance	Description	Data	Compliance	Description	Data
N/A	Ramp Length (in)	53.0	No	Ramp Slope (%)	9.9
No	Ramp Width (in)	37.0	No	Ramp XSlope (%)	5.5
N/A	Flare Type LT	N/A	N/A	Flare Type RT	N/A
N/A	Flare Slope LT (%)	N/A	N/A	Flare Slope RT (%)	N/A
N/A	Flare Traversable LT?	N/A	N/A	Flare Traversable RT?	N/A
N/A	Landing Length (in)	N/A	N/A	DWS Provided?	N/A
N/A	Landing Width (in)	N/A	N/A	DWS Contrast?	N/A
N/A	Landing Slope (%)	N/A	N/A	DWS Length (in)	N/A
N/A	Landing X Slope (%)	N/A	N/A	DWS Full Width?	N/A
N/A	Landing Curb? (Y/N)	N/A	N/A	DWS Offset (in)	N/A
N/A	Shared Landing?	N/A			
N/A	Gutter Ponding?	N/A	N/A	Gutter Slope (%)	N/A
N/A	Gutter Lip Ht (in)	N/A	N/A	Gutter X Slope (%)	N/A
N/A	Painted X Walk1?	No	N/A	Painted X Walk2?	No
	X Walk 1 Direction	To NE		X Walk 2 Direction	To NW
N/A	X Walk 1 Width (in)	N/A	N/A	X Walk 2 Width (in)	N/A
	X Walk 1 Slope (%)	4.0		X Walk 2 Slope (%)	3.6
	X Walk 1 X Slope (%)	6.1		X Walk 2 X Slope (%)	2.1

N/A	Ramp inside XWalk1?	N/A	N/A	Ramp inside XWalk2?	N/A
	Road Slope (%)	2.2	N/A	Clear Space?	N/A
	Road X Slope (%)	7.2	N/A	Clear Space to XWalk (in)	N/A
N/A	Any Obstructions?	N/A	N/A	Storm Grate/Utility Hazard?	N/A
	Obstruction Type			Storm Grate/Utility Type	
		N/A			N/A
			Yes	Surface Condition? (G/P)	Good

Remove & Replace Curb Ramp With Two New Directional Ramps or Equivalent.
