# Access Compliance Report

## Public Rights-of-Way

### (Curb Ramps)

| Intersection ID: 16513 | Main Street: BILTMORE_DR | Cross Street: COLVILLE_RD | Location: NE |

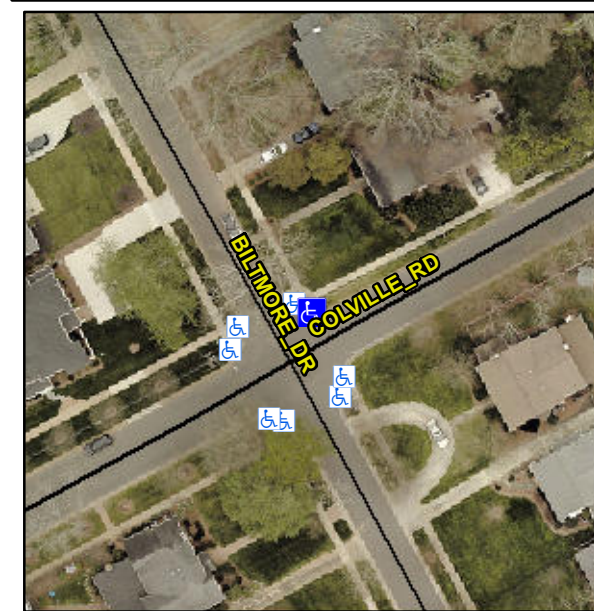
**Not Found, R304.5.1, R304.2.2, R304.5.3**

| Compliance | Description | Data | Compliance | Description | Data |
|---|---|---|---|---|---|
| N/A | Ramp Length (in) | 78.0 | No | Ramp Slope (%) | 10.2 |
| No | Ramp Width (in) | 41.0 | No | Ramp XSlope (%) | 7.1 |

**Remove & Replace Entire Ramp.**
