Access Compliance Report

Public Rights-of-Way

(Curb Ramps)

Intersection ID: 25775	Main Street: CARMEL_RD	Cross Street: PINEVILLE-MATTHEWS_RD	Location: NW
ADA ID: DB932E049E2F	Ramp Type: PerpDiag	Initial Pass/Fail: Fail	Overall Compliance: No
Severity Score: 21.25			
Codes/Mitigation Info/Possible Solution		Field Measurements/Component Compliance

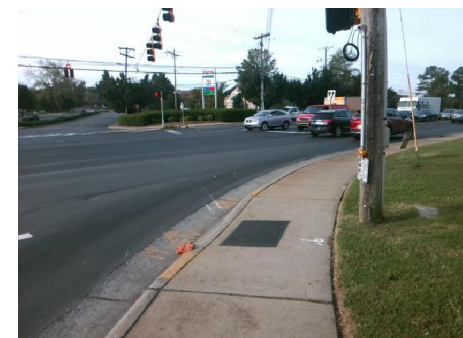
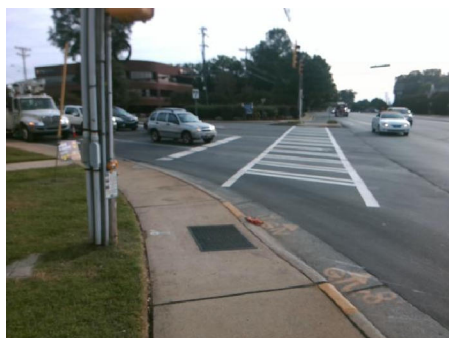
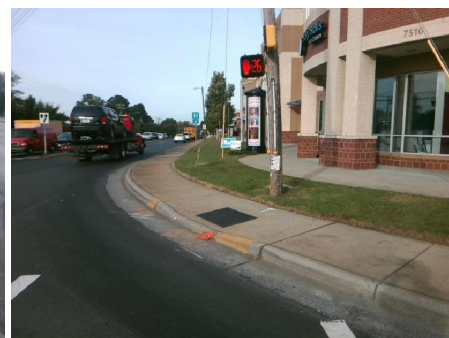
Not Found, R304.5.1, R304.2.2

Compliance	Description	Data	Compliance	Description	Data
N/A	Ramp Length (in)	59.0	No	Ramp Slope (%)	8.4
No	Ramp Width (in)	42.0	Yes	Ramp XSlope (%)	0.1
N/A	Flare Type LT	N/A	N/A	Flare Type RT	N/A
N/A	Flare Slope LT (%)	N/A	N/A	Flare Slope RT (%)	N/A
N/A	Flare Traversable LT?	N/A	N/A	Flare Traversable RT?	N/A
N/A	Landing Length (in)	N/A	N/A	DWS Provided?	N/A
N/A	Landing Width (in)	N/A	N/A	DWS Contrast?	N/A
N/A	Landing Slope (%)	N/A	N/A	DWS Length (in)	N/A
N/A	Landing X Slope (%)	N/A	N/A	DWS Full Width?	N/A
N/A	Landing Curb? (Y/N)	N/A	N/A	DWS Offset (in)	N/A
N/A	Shared Landing?	N/A			
N/A	Gutter Ponding?	N/A	N/A	Gutter Slope (%)	N/A
N/A	Gutter Lip Ht (in)	N/A	N/A	Gutter X Slope (%)	N/A
N/A	Painted X Walk1?	No	N/A	Painted X Walk2?	Yes
	X Walk 1 Direction	To SW		X Walk 2 Direction	To E
N/A	X Walk 1 Width (in)	N/A	N/A	X Walk 2 Width (in)	129.0
	X Walk 1 Slope (%)	0.1		X Walk 2 Slope (%)	0.0
	X Walk 1 X Slope (%)	1.1		X Walk 2 X Slope (%)	0.2

N/A	Ramp inside XWalk1?	N/A	N/A	Ramp inside XWalk2?	Yes
	Road Slope (%)	0.0	N/A	Clear Space?	N/A
	Road X Slope (%)	0.7	N/A	Clear Space to XWalk (in)	N/A
N/A	Any Obstructions?	N/A	N/A	Storm Grate/Utility Hazard?	N/A
	Obstruction Type			Storm Grate/Utility Type	
		N/A			N/A
		Yes		Surface Condition? (G/P)	Good

Remove & Replace Curb Ramp With Two New Directional Ramps or Equivalent.
