## Access Compliance Report Public Rights-of-Way (Curb Ramps)

Intersection ID: 10031479 Main Street: MCINTYRE\_AV Cross Street: N/A Location: S

ADA ID: DB9DD55994E1 Ramp Type: Perp Initial Pass/Fail: Fail Overall Compliance: No Severity Score: 8.75

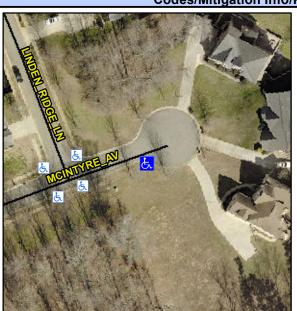
Possible Solution Field Measurements/Component Compliance							
Possible Solutions:			Comp	Data	Data Compliance Description		
Remove & Replace Ent	tire Ram	ıp.	N/A	Ramp Length (in)	46.5	Yes	Ramp Slope (%)

•	No	Ramp Width (in)	40.0	Yes	Ramp XSlope (%)
			N/A	Flare Type LT	N/A	N/A	Flare Type RT
			N/A	Flare Slope LT (%)	N/A	N/A	Flare Slope RT (%)
			N/A	Flare Traversable LT?	N/A	N/A	Flare Traversable RT?
			N/A	Landing Length (in)	N/A	N/A	DWS Provided?
Surveyor Notes:			N/A	Landing Width (in)	N/A	N/A	DWS Contrast?
N/A			N/A	Landing Slope (%)	N/A	N/A	DWS Length (in)
			N/A	Landing X Slope (%)	N/A	N/A	DWS Full Width?
			N/A	Landing Curb? (Y/N)	N/A	N/A	DWS Offset (in)
			N/A	Shared Landing?	N/A		
PROW/ADA:			N/A	Gutter Ponding?	N/A	N/A	Gutter Slope (%)
R304.5.1			N/A	Gutter Lip Ht (in)	N/A	N/A	Gutter X Slope (%)
			N/A	Painted X Walk1?	No	N/A	Painted X Walk2?
				X Walk 1 Direction	To N		X Walk 2 Direction
			N/A	X Walk 1 Width (in)	N/A	N/A	X Walk 2 Width (in)
				X Walk 1 Slope (%)	4.6		X Walk 2 Slope (%)
				X Walk 1 X Slope (%)	7.7		X Walk 2 X Slope (%)
			N/A	Ramp inside XWalk1?	N/A	N/A	Ramp inside XWalk2?

Road Slope (%)	7.7	N/A	Clear Space?
				Road X Slope (%)	4.6	N/A	Clear Space to XWalk (in)
			N/A	Any Obstructions?	N/A	N/A	Storm Grate/Utility Hazard?
Total Cost:	\$	1850.00		Obstruction Type			Storm Grate/Utility Type
