Access Compliance Report Public Rights-of-Way (Curb Ramps)

Intersection ID: 14193 Main Street: E_5TH_ST Cross Street: N_CASWELL_RD Location: NW **ADA ID: DBC33AAD3BA6** Ramp Type: Perp Initial Pass/Fail: Fail **Overall Compliance: No Severity Score:** 25

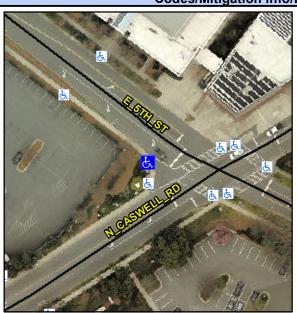
Field Measurements/Component Compliance							
Comp	liance Description	Data	Comp	oliance Description	Data		
N/A	Ramp Length (in)	60.0	No	Ramp Slope (%)	10.0		
Yes	Ramp Width (in)	50.0	No	Ramp XSlope (%)	6.8		
N/A	Flare Type LT	N/A	N/A	Flare Type RT	N/A		
N/A	Flare Slope LT (%)	N/A	N/A	Flare Slope RT (%)	N/A		
N/A	Flare Traversable LT?	N/A	N/A	Flare Traversable RT?	N/A		
N/A	Landing Length (in)	N/A	N/A	DWS Provided?	N/A		
N/A	Landing Width (in)	N/A	N/A	DWS Contrast?	N/A		
N/A	Landing Slope (%)	N/A	N/A	DWS Length (in)	N/A		
N/A	Landing X Slope (%)	N/A	N/A	DWS Full Width?	N/A		
N/A	Landing Curb? (Y/N)	N/A	N/A	DWS Offset (in)	N/A		
N/A	Shared Landing?	N/A					
N/A	Gutter Ponding?	N/A	N/A	Gutter Slope (%)	N/A		
N/A	Gutter Lip Ht (in)	N/A	N/A	Gutter X Slope (%)	N/A		
N/A	Painted X Walk1?	Yes	N/A	Painted X Walk2?	N/A		
	X Walk 1 Direction	To SE		X Walk 2 Direction	N/A		
N/A	X Walk 1 Width (in)	108.0	N/A	X Walk 2 Width (in)	N/A

X Walk 1 Slope (%)	0.1		X Walk 2 Slope (%)	N/A		
	X Walk 1 X Slope (%)	4.8		X Walk 2 X Slope (%)	N/A		
N/A	Ramp inside XWalk1?	Yes	N/A	Ramp inside XWalk2?	N/A		
	Road Slope (%)	N/A	N/A	Clear Space?	N/A		
	Road X Slope (%)	N/A	N/A	Clear Space to XWalk (in)	N/A		
N/A	Any Obstructions?	N/A	N/A	Storm Grate/Utility Hazard?	N/A		
	Obstruction Type			Storm Grate/Utility Type			
		N/A			N/A		
			Yes	Surface Condition? (G/P)	Good

Possible Solutions: Remove & Replace Entire Ramp. Surveyor Notes: N/A PROW/ADA: Not Found, R304.2.2, R304.5.3
