# Access Compliance Report

## Public Rights-of-Way

### (Curb Ramps)

| Intersection ID: 49383 | Main Street: CORRIENTE_CT | Cross Street: SOUTH_DEVON_ST | Location: S |

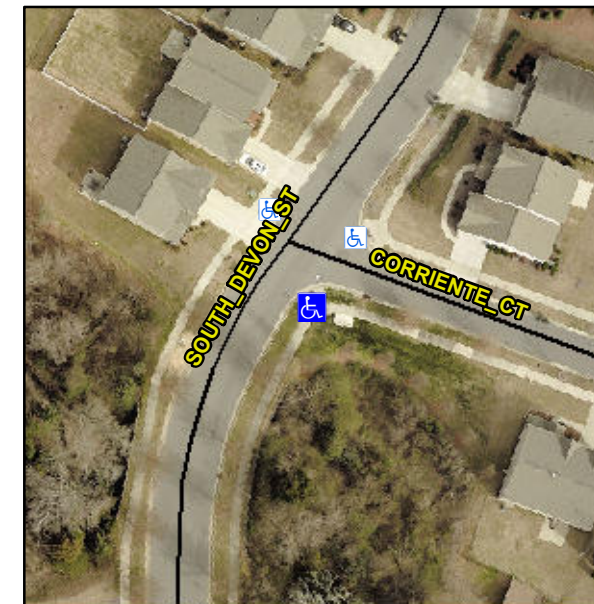
| ADA ID: DBCEC44AE418 | Ramp Type: PerpDiag | Initial Pass/Fail: Fail | Overall Compliance: No |
| | | Severity Score: 10 | |

**Not Found, R304.5.1, R304.5.3**

| Compliance | Description | Data | Compliance | Description | Data |
|---|---|---|---|---|---|
| N/A | Ramp Length (in) | 100.0 | Yes | Ramp Slope (%) | 7.6 |
| No | Ramp Width (in) | 45.5 | No | Ramp XSlope (%) | 2.3 |

**Remove & Replace Curb Ramp With Two New Directional Ramps or Equivalent.**

Total Cost: \$ 3200.00
