Access Compliance Report

Public Rights-of-Way

(Curb Ramps)

Intersection ID: 28863	Main Street: HAMPTON_PLACE_DR	Cross Street: DELAMERE_LN	Location:	N
ADA ID: DBD9237DDD93	Ramp Type: PerpDiag	Initial Pass/Fail: Fail	Overall Compliance: No	Severity Score: 1.25
Codes/Mitigation Info/Possible Solution		Field Measurements/Component Compliance

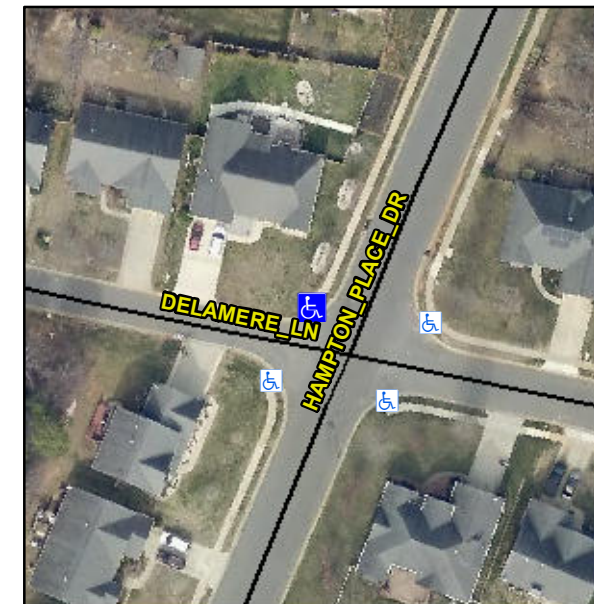
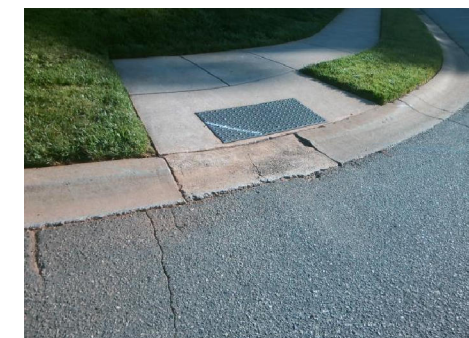
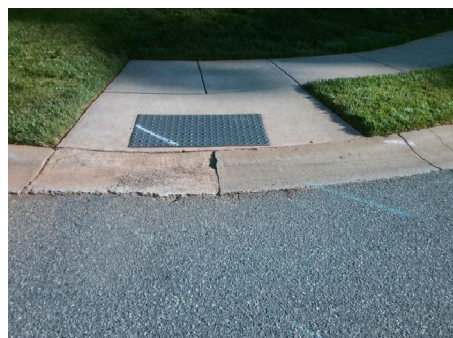
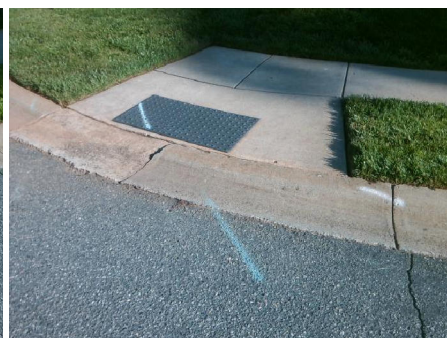
Not Found, R304.5.3

Compliance	Description	Data	Compliance	Description	Data
N/A	Ramp Length (in)	48.5	Yes	Ramp Slope (%)	6.2
Yes	Ramp Width (in)	48.0	No	Ramp XSlope (%)	2.5
N/A	Flare Type LT	N/A	N/A	Flare Type RT	N/A
N/A	Flare Slope LT (%)	N/A	N/A	Flare Slope RT (%)	N/A
N/A	Flare Traversable LT?	N/A	N/A	Flare Traversable RT?	N/A
N/A	Landing Length (in)	N/A	N/A	DWS Provided?	N/A
N/A	Landing Width (in)	N/A	N/A	DWS Contrast?	N/A
N/A	Landing Slope (%)	N/A	N/A	DWS Length (in)	N/A
N/A	Landing X Slope (%)	N/A	N/A	DWS Full Width?	N/A
N/A	Landing Curb? (Y/N)	N/A	N/A	DWS Offset (in)	N/A
N/A	Shared Landing?	N/A			
N/A	Gutter Ponding?	N/A	N/A	Gutter Slope (%)	N/A
N/A	Gutter Lip Ht (in)	N/A	N/A	Gutter X Slope (%)	N/A
N/A	Painted X Walk1?	No	N/A	Painted X Walk2?	No
	X Walk 1 Direction	To SW		X Walk 2 Direction	To SE
N/A	X Walk 1 Width (in)	N/A	N/A	X Walk 2 Width (in)	N/A
	X Walk 1 Slope (%)	1.2		X Walk 2 Slope (%)	1.1
	X Walk 1 X Slope (%)	1.9		X Walk 2 X Slope (%)	0.7

N/A	Ramp inside XWalk1?	N/A	N/A	Ramp inside XWalk2?	N/A
	Road Slope (%)	0.5	N/A	Clear Space?	N/A
	Road X Slope (%)	2.2	N/A	Clear Space to XWalk (in)	N/A
N/A	Any Obstructions?	N/A	N/A	Storm Grate/Utility Hazard?	N/A
	Obstruction Type			Storm Grate/Utility Type	
		N/A			N/A
			Yes	Surface Condition? (G/P)	Good

Remove & Replace Curb Ramp With Two New Directional Ramps or Equivalent.
