Access Compliance Report

Public Rights-of-Way

(Curb Ramps)

Intersection ID: 13857	Main Street: ALBEMARLE_RD	Cross Street: DENBUR_DR	Location: W
ADA ID: DBDC788D3324	Ramp Type: Perp	Initial Pass/Fail: Fail	Overall Compliance: No
Severity Score: 21.25			
Codes/Mitigation Info/Possible Solution		Field Measurements/Component Compliance

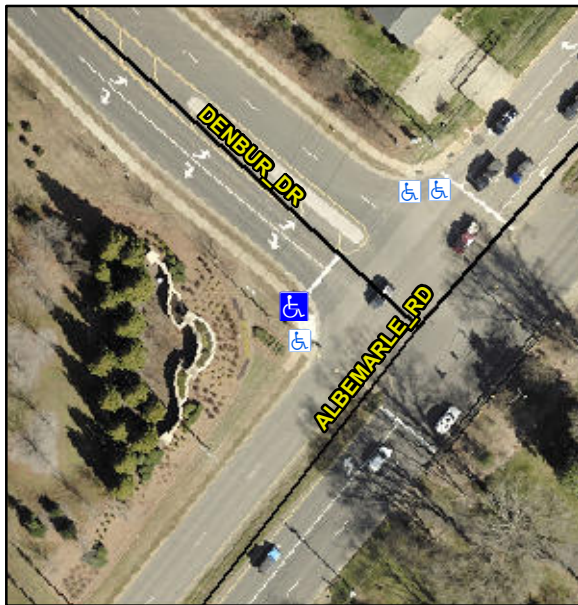
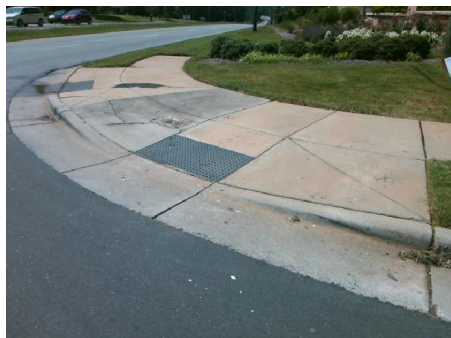
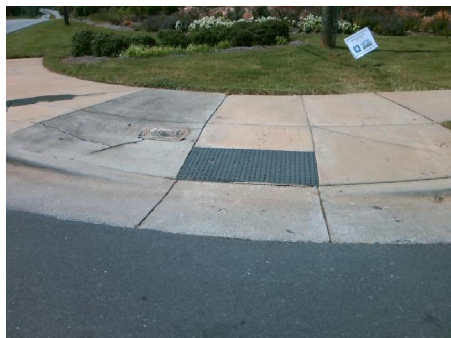
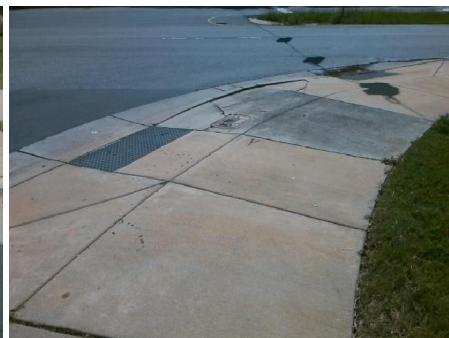
Not Found, R304.5.1, R304.2.2

Compliance	Description	Data	Compliance	Description	Data
N/A	Ramp Length (in)	50.0	No	Ramp Slope (%)	11.5
No	Ramp Width (in)	47.0	Yes	Ramp XSlope (%)	1.8
N/A	Flare Type LT	N/A	N/A	Flare Type RT	N/A
N/A	Flare Slope LT (%)	N/A	N/A	Flare Slope RT (%)	N/A
N/A	Flare Traversable LT?	N/A	N/A	Flare Traversable RT?	N/A
N/A	Landing Length (in)	N/A	N/A	DWS Provided?	N/A
N/A	Landing Width (in)	N/A	N/A	DWS Contrast?	N/A
N/A	Landing Slope (%)	N/A	N/A	DWS Length (in)	N/A
N/A	Landing X Slope (%)	N/A	N/A	DWS Full Width?	N/A
N/A	Landing Curb? (Y/N)	N/A	N/A	DWS Offset (in)	N/A
N/A	Shared Landing?	N/A			
N/A	Gutter Ponding?	N/A	N/A	Gutter Slope (%)	N/A
N/A	Gutter Lip Ht (in)	N/A	N/A	Gutter X Slope (%)	N/A
N/A	Painted X Walk1?	No	N/A	Painted X Walk2?	N/A
	X Walk 1 Direction	To NE		X Walk 2 Direction	N/A
N/A	X Walk 1 Width (in)	N/A	N/A	X Walk 2 Width (in)	N/A
	X Walk 1 Slope (%)	0.5		X Walk 2 Slope (%)	N/A
	X Walk 1 X Slope (%)	1.4		X Walk 2 X Slope (%)	N/A

N/A	Ramp inside XWalk1?	N/A	N/A	Ramp inside XWalk2?	N/A
	Road Slope (%)	N/A	N/A	Clear Space?	N/A
	Road X Slope (%)	N/A	N/A	Clear Space to XWalk (in)	N/A
N/A	Any Obstructions?	N/A	N/A	Storm Grate/Utility Hazard?	N/A
	Obstruction Type			Storm Grate/Utility Type	
		N/A			N/A
			Yes	Surface Condition? (G/P)	Good

Possible Solutions:

Remove & Replace Entire Ramp.
