# Access Compliance Report

## Public Rights-of-Way (Curb Ramps)

Intersection ID: 50338	Main Street: HERMISTON_ST	Cross Street: CASTLECOVE_RD	Location: NW
ADA ID: DBE5680DA3F8	Ramp Type: Para	Initial Pass/Fail: Fail	Overall Compliance: No
		Severity Score: 12.5

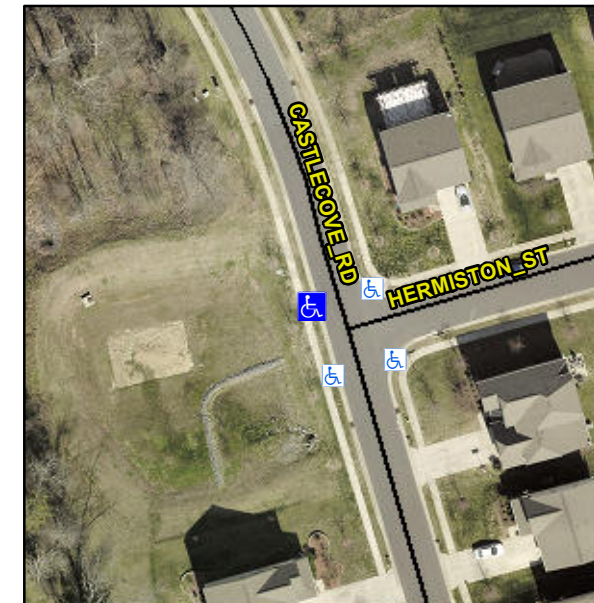
Compliance	Description	Data	Compliance	Description	Data
N/A	Ramp Length LT (in)	42.5	N/A	Ramp Length RT (in)	39.0
Yes	Ramp Width LT (in)	96.0	Yes	Ramp Width RT (in)	96.0
No	Ramp Slope LT (%)	10.3	Yes	Ramp Slope RT (%)	7.0
Yes	Ramp XSlope LT (%)	1.0	Yes	Ramp XSlope RT (%)	1.2
N/A	Landing Length (in)	N/A	N/A	DWS Provided?	N/A
N/A	Landing Width (in)	N/A	N/A	DWS Contrast?	N/A
N/A	Landing Slope (%)	N/A	N/A	DWS Length (in)	N/A
N/A	Landing X Slope (%)	N/A	N/A	DWS Full Width?	N/A
N/A	Landing Curb? (Y/N)	N/A	N/A	DWS Offset (in)	N/A
N/A	Shared Landing?	N/A			
N/A	Gutter Ponding?	N/A	N/A	Gutter Slope (%)	N/A
N/A	Gutter Lip Ht (in)	N/A	N/A	Gutter X Slope (%)	N/A
N/A	Painted X Walk1?	No	N/A	Painted X Walk2?	N/A
	X Walk 1 Direction	To NE		X Walk 2 Direction	N/A
N/A	X Walk 1 Width (in)	N/A	N/A	X Walk 2 Width (in)	N/A
	X Walk 1 Slope (%)	2.5		X Walk 2 Slope (%)	N/A
	X Walk 1 X Slope (%)	2.0		X Walk 2 X Slope (%)	N/A
N/A	Ramp inside XWalk1?	N/A	N/A	Ramp inside XWalk2?	N/A

Road Slope (%)	N/A	N/A	Clear Space?	N/A
	Road X Slope (%)	N/A	N/A	Clear Space to XWalk (in)	N/A
N/A	Any Obstructions?	N/A	N/A	Storm Grate/Utility Hazard?	N/A
	Obstruction Type			Storm Grate/Utility Type	
		N/A			N/A
			Yes	Surface Condition? (G/P)	Good
			N/A	Curb Slope (%)	3.0

**Remove & Replace Entire Ramp.**

**R304.3.2**
