Access Compliance Report

Public Rights-of-Way

(Curb Ramps)

Intersection ID: 7979	Main Street: EAGLE PEAK DR	Cross Street: DAVID AV	Location: W
ADA ID: DBF43EF65C2D	Ramp Type: Perp	Initial Pass/Fail: Fail	Overall Compliance: No
			Severity Score: 33.75

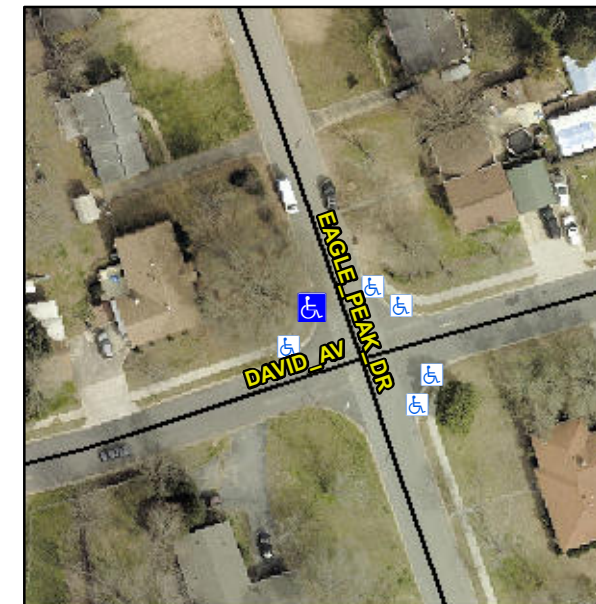
Not Found, R304.5.1, R304.2.2, R304.5.3

Compliance	Description	Data	Compliance	Description	Data
N/A	Ramp Length (in)	48.0	No	Ramp Slope (%)	8.4
No	Ramp Width (in)	46.5	No	Ramp XSlope (%)	6.1
N/A	Flare Type LT	N/A	N/A	Flare Type RT	N/A
N/A	Flare Slope LT (%)	N/A	N/A	Flare Slope RT (%)	N/A
N/A	Flare Traversable LT?	N/A	N/A	Flare Traversable RT?	N/A
N/A	Landing Length (in)	N/A	N/A	DWS Provided?	N/A
N/A	Landing Width (in)	N/A	N/A	DWS Contrast?	N/A
N/A	Landing Slope (%)	N/A	N/A	DWS Length (in)	N/A
N/A	Landing X Slope (%)	N/A	N/A	DWS Full Width?	N/A
N/A	Landing Curb? (Y/N)	N/A	N/A	DWS Offset (in)	N/A
N/A	Shared Landing?	N/A			
N/A	Gutter Ponding?	N/A	N/A	Gutter Slope (%)	N/A
N/A	Gutter Lip Ht (in)	2.0	N/A	Gutter X Slope (%)	N/A
N/A	Painted X Walk1?	No	N/A	Painted X Walk2?	N/A
	X Walk 1 Direction	To E		X Walk 2 Direction	N/A
N/A	X Walk 1 Width (in)	N/A	N/A	X Walk 2 Width (in)	N/A
	X Walk 1 Slope (%)	0.4		X Walk 2 Slope (%)	N/A
	X Walk 1 X Slope (%)	5.5		X Walk 2 X Slope (%)	N/A

N/A	Ramp inside XWalk1?	N/A	N/A	Ramp inside XWalk2?	N/A
	Road Slope (%)	N/A	N/A	Clear Space?	N/A
	Road X Slope (%)	N/A	N/A	Clear Space to XWalk (in)	N/A
N/A	Any Obstructions?	N/A	N/A	Storm Grate/Utility Hazard?	N/A
	Obstruction Type			Storm Grate/Utility Type	
		N/A			N/A
			Yes	Surface Condition? (G/P)	Good

Possible Solutions:

Remove & Replace Entire Ramp.
