Access Compliance Report

Public Rights-of-Way

| Intersection ID: 25122 | Main Street: COPPER_RIDGE_TL | Cross Street: LAVENDER_TRACE_CT | Location: SW |
| ADA ID: DBF7F9B9C37B | Ramp Type: Perp | Initial Pass/Fail: Fail | Overall Compliance: No |

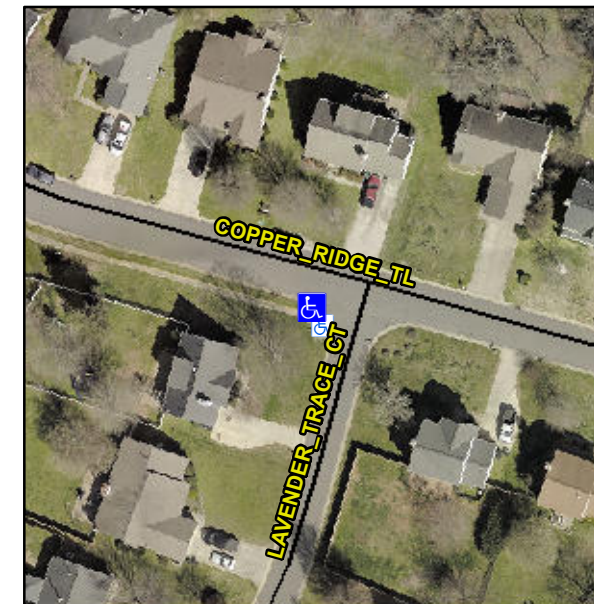
| Severity Score: 36.25 | | | |

R304.5.1, R304.5.3

| Compliance | Description | Data | Compliance | Description | Data |
|---|---|---|---|---|---|
| No | Ramp Width (in) | 25.0 | No | Ramp XSlope (%) | 3.1 |

Remove & Replace Entire Ramp.

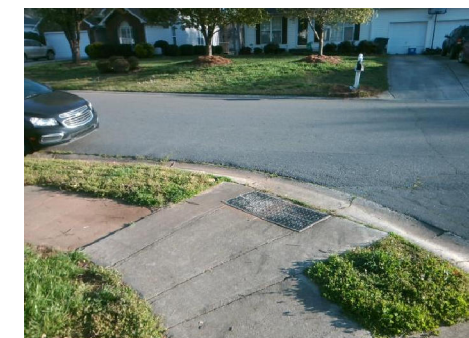
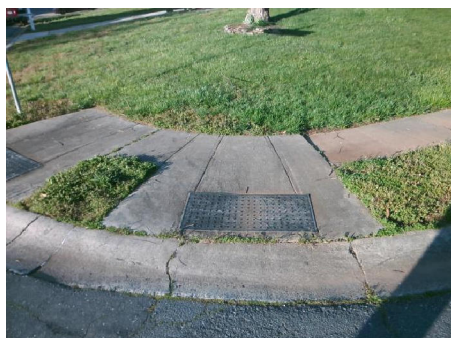
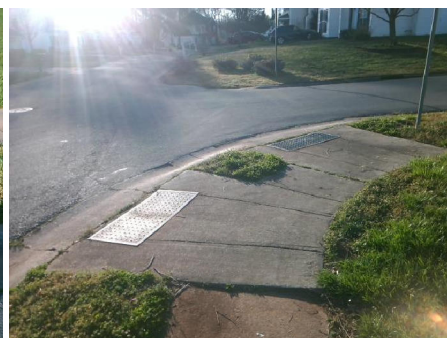
| Compliance | Description | Data | Compliance | Description | Data |
|---|---|---|---|---|---|
| N/A | Ramp Length (in) | 93.0 | Yes | Ramp Slope (%) | 7.2 |
| | | | Yes | Surface Condition? (G/P) | Good |
