Intersection ID: N/A	Main Street: SPRATT_ST	Cross Street: N/A	Location:	SW
ADA ID: DBFB49B155D0	Ramp Type: Perp	Initial Pass/Fail: Fail	Overall Compliance: No	Severity Score: 13.75

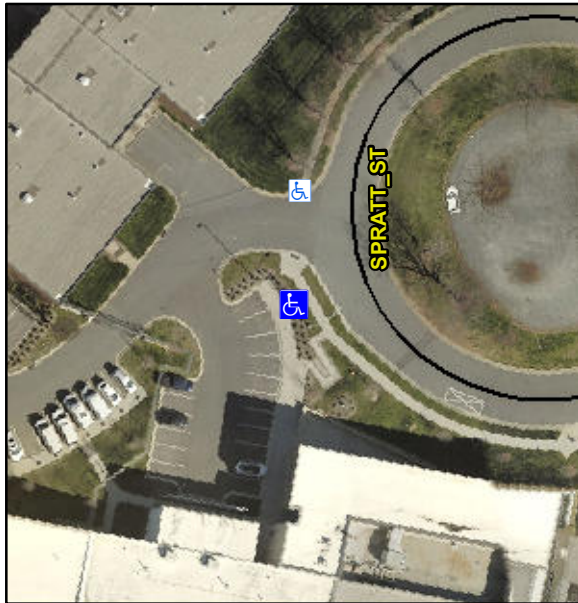
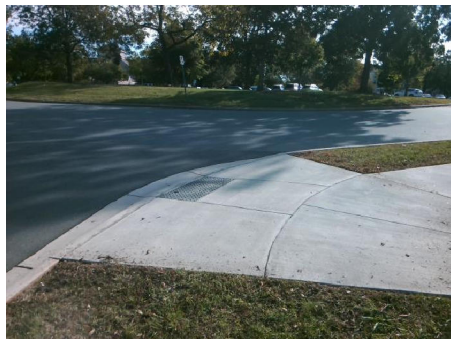
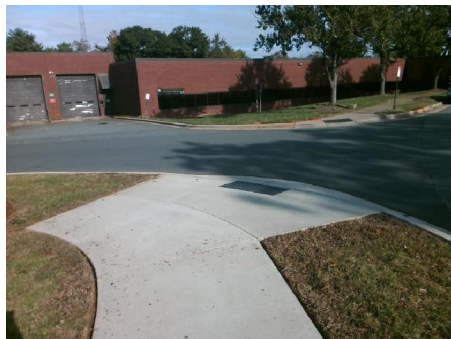
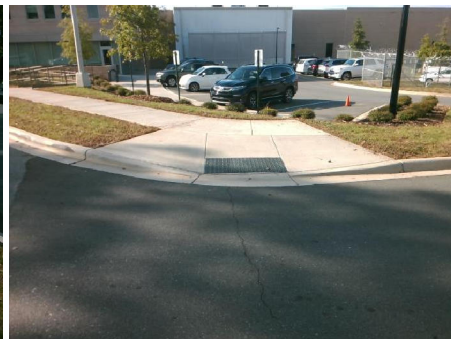
Not Found, R304.2.2

Possible Solutions:			Compliance	Description	Data	Compliance	Description	Data
Remove & Replace Entire Ramp.			N/A	Ramp Length (in)	74.0	No	Ramp Slope (%)	9.4
			Yes	Ramp Width (in)	48.0	Yes	Ramp XSlope (%)	3.3
			N/A	Flare Type LT	N/A	N/A	Flare Type RT	N/A
			N/A	Flare Slope LT (%)	N/A	N/A	Flare Slope RT (%)	N/A
			N/A	Flare Traversable LT?	N/A	N/A	Flare Traversable RT?	N/A
			N/A	Landing Length (in)	N/A	N/A	DWS Provided?	N/A
			N/A	Landing Width (in)	N/A	N/A	DWS Contrast?	N/A
			N/A	Landing Slope (%)	N/A	N/A	DWS Length (in)	N/A
			N/A	Landing X Slope (%)	N/A	N/A	DWS Full Width?	N/A
			N/A	Landing Curb? (Y/N)	N/A	N/A	DWS Offset (in)	N/A
Surveyor Notes: N/A			N/A	Shared Landing?	N/A			
			N/A	Gutter Ponding?	N/A	N/A	Gutter Slope (%)	N/A
			N/A	Gutter Lip Ht (in)	N/A	N/A	Gutter X Slope (%)	N/A
			N/A	Painted X Walk1?	No	N/A	Painted X Walk2?	N/A
				X Walk 1 Direction	To N		X Walk 2 Direction	N/A
			N/A	X Walk 1 Width (in)	N/A	N/A	X Walk 2 Width (in)	N/A

X Walk 1 Slope (%)	1.5		X Walk 2 Slope (%)	N/A
				X Walk 1 X Slope (%)	4.9		X Walk 2 X Slope (%)	N/A
			N/A	Ramp inside XWalk1?	N/A	N/A	Ramp inside XWalk2?	N/A
				Road Slope (%)	N/A	N/A	Clear Space?	N/A
PROW/ADA: Not Found, R304.2.2				Road X Slope (%)	N/A	N/A	Clear Space to XWalk (in)	N/A
			N/A	Any Obstructions?	N/A	N/A	Storm Grate/Utility Hazard?	N/A
				Obstruction Type			Storm Grate/Utility Type	
					N/A			N/A
						Yes	Surface Condition? (G/P)	Good
Total Cost:			\$	1850.00

Remove & Replace Entire Ramp.
