# Access Compliance Report

## Public Rights-of-Way

| Intersection ID: N/A | Main Street: MAYNARD_RD | Cross Street: MARICOPIA_RIDGE_LN | Location: SW |
| ADA ID: DC04B3F1BB19 | Ramp Type: Perp | Initial Pass/Fail: Fail | Overall Compliance: No |

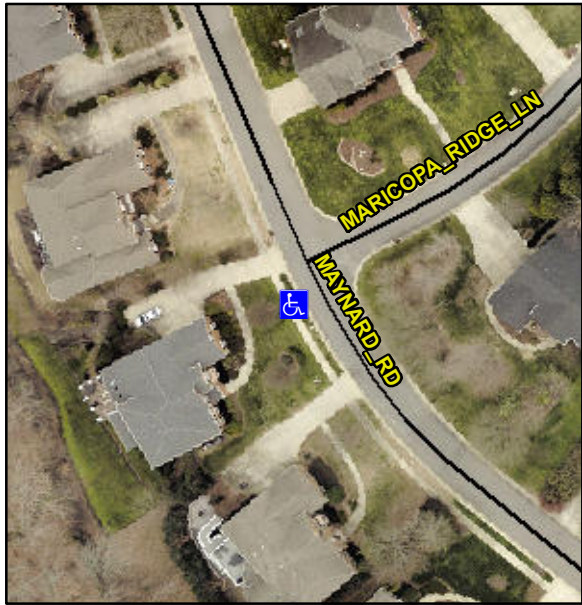
| | | Severity Score: 10 | |

| Codes/Mitigation Info/Possible Solution | | | Field Measurements/Component Compliance | | | | | | | | | | | | | |
|--|---|---|---|---|--|---|--|---|---|---|---|--|---|--|--|---|
| | | | No | Ramp Width (in) | | 44.3 | | Yes | Ramp XSlope (%) | | 3.3 | | | | | |
| PROW/ADA: | | R304.5.1 | N/A | Gutter Ponding? | | N/A | | N/A | Gutter Slope (%) | | N/A | | | | | |

| Codes/Mitigation Info/Possible Solution | | | Field Measurements/Component Compliance | | | | | | | | | | | | | |
|--|---|---|---|---|--|---|--|---|---|---|---|--|---|--|--|---|
| | Remove & Replace Entire Ramp. | | N/A | Ramp Length (in) | | 48.0 | | Yes | Ramp Slope (%) | | 5.0 | | | | | |
