Stop Condition-Street 1WITHAM PASSAGE

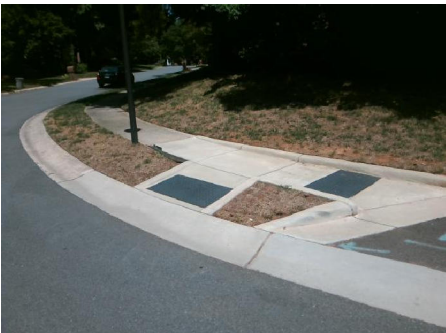
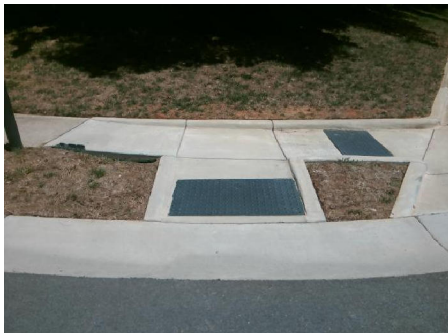
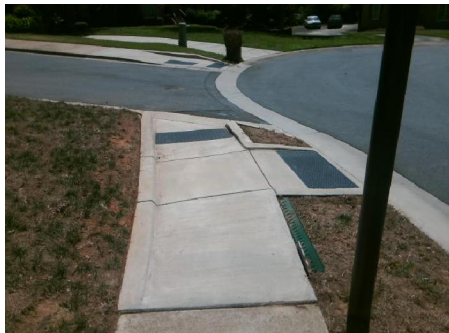
Not Found, R304.5.1, R304.2.2, R304.5.3, R304.3.2

Compliance	Description	Data	Compliance	Description	Data
N/A	Ramp Length LT (in)	55.0	N/A	Ramp Length RT (in)	N/A
No	Ramp Width LT (in)	42.0	N/A	Ramp Width RT (in)	N/A
No	Ramp Slope LT (%)	10.0	N/A	Ramp Slope RT (%)	N/A
Yes	Ramp XSlope LT (%)	1.5	N/A	Ramp XSlope RT (%)	N/A
N/A	Ramp Length (in)	42.0	No	Ramp Slope (%)	16.4
Yes	Ramp Width (in)	49.0	No	Ramp XSlope (%)	6.0
N/A	Flare Type LT	N/A	N/A	Flare Type RT	N/A
N/A	Flare Slope LT (%)	N/A	N/A	Flare Slope RT (%)	N/A
N/A	Flare Traversable LT?	N/A	N/A	Flare Traversable RT?	N/A
N/A	Landing Length (in)	N/A	N/A	DWS Provided?	N/A
N/A	Landing Width (in)	N/A	N/A	DWS Contrast?	N/A
N/A	Landing Slope (%)	N/A	N/A	DWS Length (in)	N/A
N/A	Landing X Slope (%)	N/A	N/A	DWS Full Width?	N/A
N/A	Landing Curb? (Y/N)	N/A	N/A	DWS Offset (in)	N/A
N/A	Shared Landing?	N/A			
N/A	Gutter Ponding?	N/A	N/A	Gutter Slope (%)	N/A
N/A	Gutter Lip Ht (in)	N/A	N/A	Gutter X Slope (%)	N/A
N/A	Painted X Walk1?	No	N/A	Painted X Walk2?	N/A

X Walk 1 Direction	To SW		X Walk 2 Direction	N/A
	X Walk 1 Width (in)	N/A		X Walk 2 Width (in)	N/A
	X Walk 1 Slope (%)	6.7		X Walk 2 Slope (%)	N/A
	X Walk 1 X Slope (%)	1.1		X Walk 2 X Slope (%)	N/A
N/A	Ramp inside XWalk1?	N/A	N/A	Ramp inside XWalk2?	N/A
	Road Slope (%)	N/A		Clear Space?	N/A
	Road X Slope (%)	N/A	N/A	Clear Space to XWalk (in)	N/A
			N/A	Any Obstruction?	N/A
				Obstruction Type	N/A
			N/A	Storm Grate/Utility Hazard?	N/A
				Storm Grate/Utility Type	N/A
			Yes	Surface Condition? (G/P)	Good
				Curb Slope (%)	30.5

Remove & Replace Entire Ramp.
