# Access Compliance Report

## Public Rights-of-Way

### (Curb Ramps)

Intersection ID: 10025796	Main Street: EDGEHILL_RD_NORTH	Cross Street: N/A	Location: SE
ADA ID: DC16BCC5DF3A	Ramp Type: PerpDiag	Initial Pass/Fail: Fail	Overall Compliance: No
Codes/Mitigation Info/Possible Solution		Field Measurements/Component Compliance	
Severity Score: 10

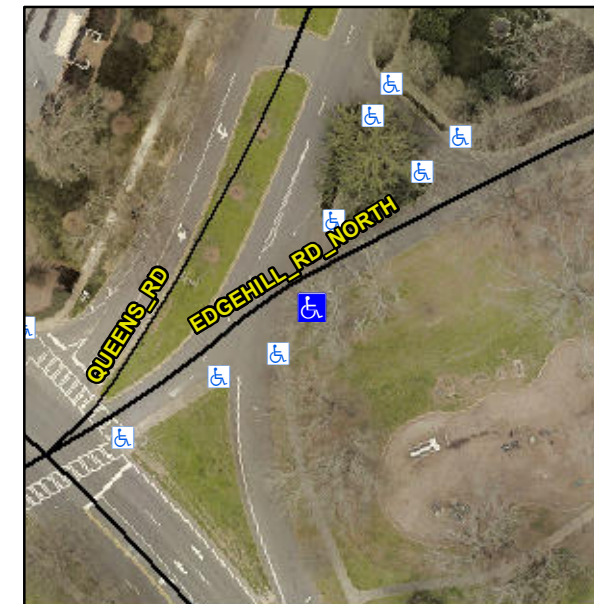
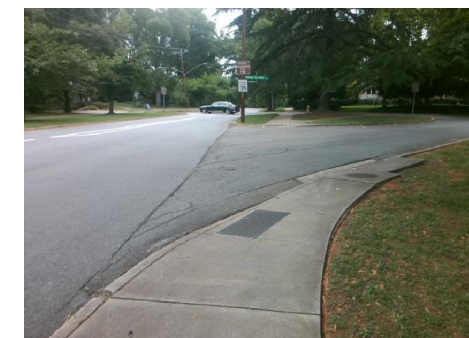
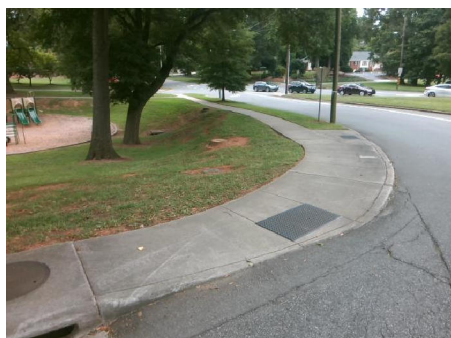
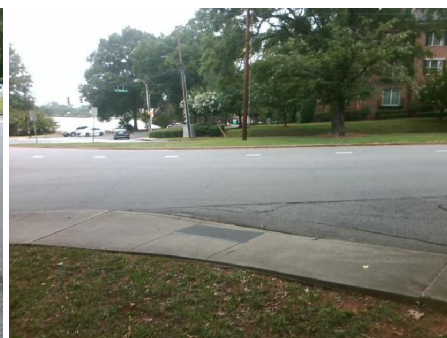
**Not Found, R304.5.1, R304.5.3**

Compliance	Description	Data	Compliance	Description	Data
N/A	Ramp Length (in)	59.0	Yes	Ramp Slope (%)	6.2
No	Ramp Width (in)	41.0	No	Ramp XSlope (%)	4.6
N/A	Flare Type LT	N/A	N/A	Flare Type RT	N/A
N/A	Flare Slope LT (%)	N/A	N/A	Flare Slope RT (%)	N/A
N/A	Flare Traversable LT?	N/A	N/A	Flare Traversable RT?	N/A
N/A	Landing Length (in)	N/A	N/A	DWS Provided?	N/A
N/A	Landing Width (in)	N/A	N/A	DWS Contrast?	N/A
N/A	Landing Slope (%)	N/A	N/A	DWS Length (in)	N/A
N/A	Landing X Slope (%)	N/A	N/A	DWS Full Width?	N/A
N/A	Landing Curb? (Y/N)	N/A	N/A	DWS Offset (in)	N/A
N/A	Shared Landing?	N/A			
N/A	Gutter Ponding?	N/A	N/A	Gutter Slope (%)	N/A
N/A	Gutter Lip Ht (in)	N/A	N/A	Gutter X Slope (%)	N/A
N/A	Painted X Walk1?	No	N/A	Painted X Walk2?	No
	X Walk 1 Direction	To NE		X Walk 2 Direction	To NW
N/A	X Walk 1 Width (in)	N/A	N/A	X Walk 2 Width (in)	N/A
	X Walk 1 Slope (%)	6.9		X Walk 2 Slope (%)	4.0
	X Walk 1 X Slope (%)	6.0		X Walk 2 X Slope (%)	5.1

N/A	Ramp inside XWalk1?	N/A	N/A	Ramp inside XWalk2?	N/A
	Road Slope (%)	2.2	N/A	Clear Space?	N/A
	Road X Slope (%)	13.8	N/A	Clear Space to XWalk (in)	N/A
N/A	Any Obstructions?	N/A	N/A	Storm Grate/Utility Hazard?	N/A
	Obstruction Type			Storm Grate/Utility Type	
		N/A			N/A
		Yes		Surface Condition? (G/P)	Good

**Remove & Replace Curb Ramp With Two New Directional Ramps or Equivalent.**
