# Access Compliance Report

## Public Rights-of-Way

### (Curb Ramps)

Intersection ID: 12329	Main Street: E_15TH_ST	Cross Street: PEGRAM_ST	Location: W
ADA ID: DC194B0532EE	Ramp Type: BlendTrans1	Initial Pass/Fail: Fail	Overall Compliance: No
			Severity Score: 21.25

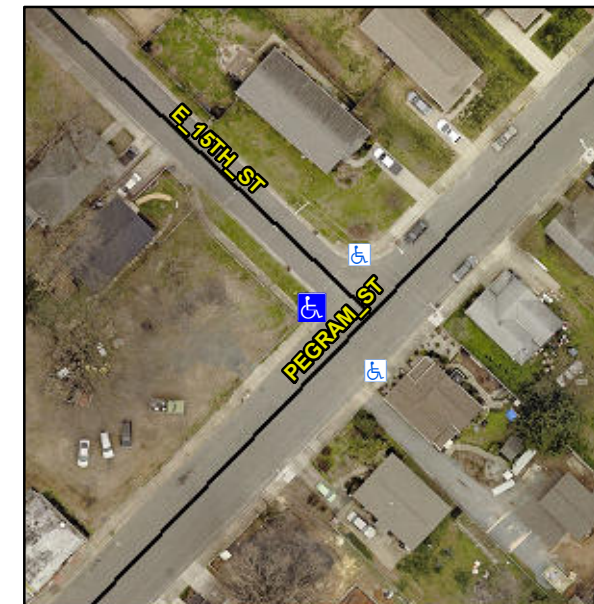
**Not Found, R304.5.1, R304.5.3**

Compliance	Description	Data	Compliance	Description	Data
N/A	Ramp Length (in)	31.0	Yes	BlendTrans Slope (%)	2.3
No	Ramp Width (in)	40.0	No	BlendTrans XSlope (%)	6.1
N/A	Flare Type LT	N/A	N/A	Flare Type RT	N/A
N/A	Flare Slope LT (%)	N/A	N/A	Flare Slope RT (%)	N/A
N/A	Flare Traversable LT?	N/A	N/A	Flare Traversable RT?	N/A
N/A	Landing Length (in)	N/A	N/A	DWS Provided?	N/A
N/A	Landing Width (in)	N/A	N/A	DWS Contrast?	N/A
N/A	Landing Slope (%)	N/A	N/A	DWS Length (in)	N/A
N/A	Landing X Slope (%)	N/A	N/A	DWS Full Width?	N/A
N/A	Landing Curb? (Y/N)	N/A	N/A	DWS Offset (in)	N/A
N/A	Shared Landing?	N/A			
N/A	Gutter Ponding?	N/A	N/A	Gutter Slope (%)	N/A
N/A	Gutter Lip Ht (in)	N/A	N/A	Gutter X Slope (%)	N/A
N/A	Painted X Walk1?	No	N/A	Painted X Walk2?	No
	X Walk 1 Direction	To SE		X Walk 2 Direction	To NE
	X Walk 1 Width (in)	N/A		X Walk 2 Width (in)	N/A
	X Walk 1 Slope (%)	4.7		X Walk 2 Slope (%)	3.9
	X Walk 1 X Slope (%)	4.3		X Walk 2 X Slope (%)	2.0

N/A	Ramp inside XWalk1?	N/A	N/A	Ramp inside XWalk2?	N/A
	Road Slope (%)	3.1		Clear Space?	N/A
	Road X Slope (%)	5.9	N/A	Clear Space to XWalk (in)	N/A
N/A	Any Obstructions?	N/A	N/A	Storm Grate/Utility Hazard?	N/A
	Obstruction Type			Storm Grate/Utility Type	
		N/A			N/A
			Yes	Surface Condition? (G/P)	Good
			No	Curb Slope (%)	31.3

**Remove & Replace Curb Ramp With Two New Directional Ramps or Equivalent.**
