# Access Compliance Report

## Public Rights-of-Way

### (Curb Ramps)

Intersection ID: 30311	Main Street: EUROSTAR_DR	Cross Street: ROCKET_LN	Location:	E
ADA ID: DC3077FD7A71	Ramp Type: PerpDiag	Initial Pass/Fail: Fail	Overall Compliance: No	Severity Score: 10

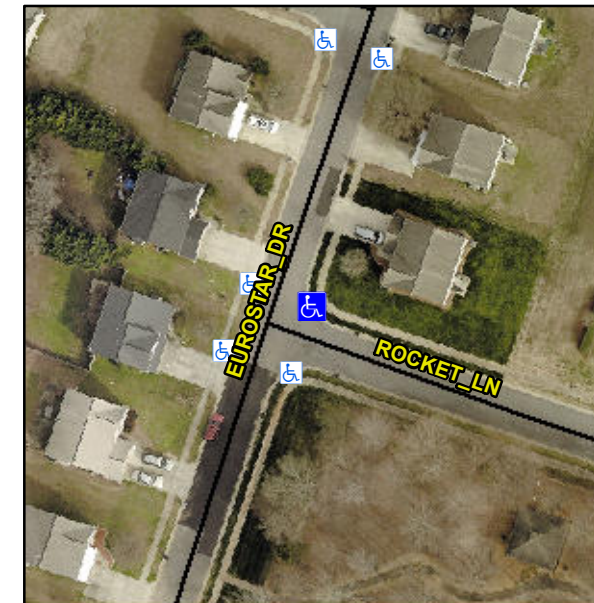
**Not Found, R304.5.1, R304.5.3**

Compliance	Description	Data	Compliance	Description	Data
N/A	Ramp Length (in)	47.0	Yes	Ramp Slope (%)	6.1
No	Ramp Width (in)	43.5	No	Ramp XSlope (%)	4.8
N/A	Flare Type LT	N/A	N/A	Flare Type RT	N/A
N/A	Flare Slope LT (%)	N/A	N/A	Flare Slope RT (%)	N/A
N/A	Flare Traversable LT?	N/A	N/A	Flare Traversable RT?	N/A
N/A	Landing Length (in)	N/A	N/A	DWS Provided?	N/A
N/A	Landing Width (in)	N/A	N/A	DWS Contrast?	N/A
N/A	Landing Slope (%)	N/A	N/A	DWS Length (in)	N/A
N/A	Landing X Slope (%)	N/A	N/A	DWS Full Width?	N/A
N/A	Landing Curb? (Y/N)	N/A	N/A	DWS Offset (in)	N/A
N/A	Shared Landing?	N/A			
N/A	Gutter Ponding?	N/A	N/A	Gutter Slope (%)	N/A
N/A	Gutter Lip Ht (in)	N/A	N/A	Gutter X Slope (%)	N/A
N/A	Painted X Walk1?	No	N/A	Painted X Walk2?	No
	X Walk 1 Direction	To NW		X Walk 2 Direction	To SW
N/A	X Walk 1 Width (in)	N/A	N/A	X Walk 2 Width (in)	N/A
	X Walk 1 Slope (%)	2.0		X Walk 2 Slope (%)	1.4
	X Walk 1 X Slope (%)	0.5		X Walk 2 X Slope (%)	4.0

N/A	Ramp inside XWalk1?	N/A	N/A	Ramp inside XWalk2?	N/A
	Road Slope (%)	5.2	N/A	Clear Space?	N/A
	Road X Slope (%)	0.0	N/A	Clear Space to XWalk (in)	N/A
N/A	Any Obstructions?	N/A	N/A	Storm Grate/Utility Hazard?	N/A
	Obstruction Type			Storm Grate/Utility Type	
		N/A			N/A
			Yes	Surface Condition? (G/P)	Good

**Remove & Replace Curb Ramp With Two New Directional Ramps or Equivalent.**

Total Cost: \$ 3200.00
