Access Compliance Report

Public Rights-of-Way

(Curb Ramps)

Intersection ID: N/A	Main Street: PERTH_MOOR_RD	Cross Street: HAMILTON_BRIDGE_RD	Location: NE
ADA ID: DC33F5838B07	Ramp Type: Perp	Initial Pass/Fail: Fail	Overall Compliance: No
		Severity Score: 25

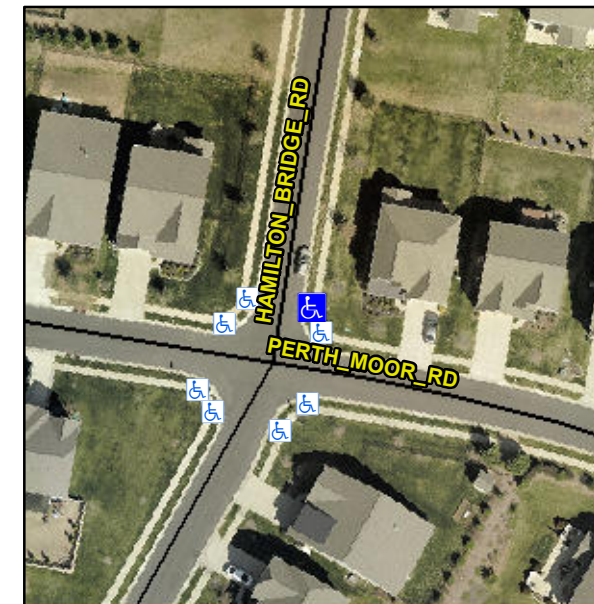
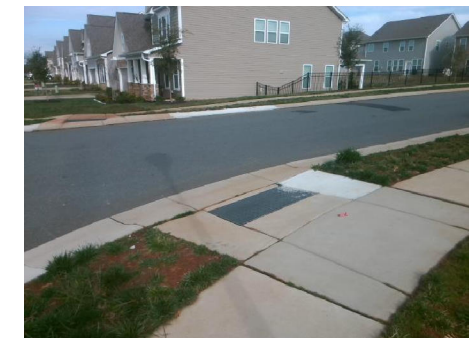
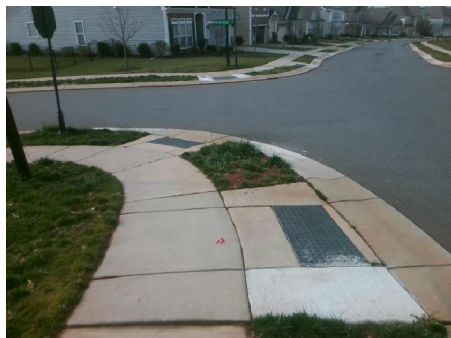
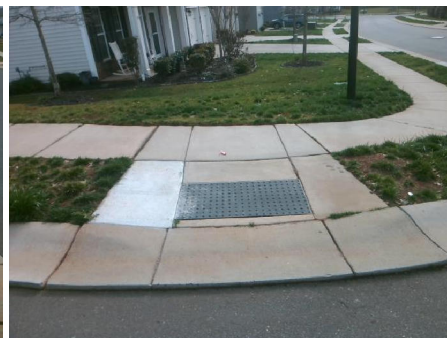
Compliance	Description	Data	Compliance	Description	Data
N/A	Ramp Length (in)	48.0	No	Ramp Slope (%)	11.5
Yes	Ramp Width (in)	48.0	No	Ramp XSlope (%)	6.8
N/A	Flare Type LT	N/A	N/A	Flare Type RT	N/A
N/A	Flare Slope LT (%)	N/A	N/A	Flare Slope RT (%)	N/A
N/A	Flare Traversable LT?	N/A	N/A	Flare Traversable RT?	N/A
N/A	Landing Length (in)	N/A	N/A	DWS Provided?	N/A
N/A	Landing Width (in)	N/A	N/A	DWS Contrast?	N/A
N/A	Landing Slope (%)	N/A	N/A	DWS Length (in)	N/A
N/A	Landing X Slope (%)	N/A	N/A	DWS Full Width?	N/A
N/A	Landing Curb? (Y/N)	N/A	N/A	DWS Offset (in)	N/A
N/A	Shared Landing?	N/A			
N/A	Gutter Ponding?	N/A	N/A	Gutter Slope (%)	N/A
N/A	Gutter Lip Ht (in)	1.0	N/A	Gutter X Slope (%)	N/A
N/A	Painted X Walk1?	No	N/A	Painted X Walk2?	N/A
	X Walk 1 Direction	To NW		X Walk 2 Direction	N/A
N/A	X Walk 1 Width (in)	N/A	N/A	X Walk 2 Width (in)	N/A
	X Walk 1 Slope (%)	1.9		X Walk 2 Slope (%)	N/A
	X Walk 1 X Slope (%)	5.4		X Walk 2 X Slope (%)	N/A

N/A	Ramp inside XWalk1?	N/A	N/A	Ramp inside XWalk2?	N/A
	Road Slope (%)	N/A	N/A	Clear Space?	N/A
	Road X Slope (%)	N/A	N/A	Clear Space to XWalk (in)	N/A
N/A	Any Obstructions?	N/A	N/A	Storm Grate/Utility Hazard?	N/A
	Obstruction Type			Storm Grate/Utility Type	
		N/A			N/A
			Yes	Surface Condition? (G/P)	Good

Remove & Replace Entire Ramp.

R304.2.2, R304.5.3

\$ 1850.00
