## Access Compliance Report Public Rights-of-Way (Curb Ramps)

Intersection ID: 27490 Main Street: BALLANTYNE\_COMMONS\_PY Cross Street: JOHNSTON\_RD Location: NE

ADA ID: DC3797F50DB0 Ramp Type: Perp Initial Pass/Fail: Fail Overall Compliance: No Severity Score: 12.5

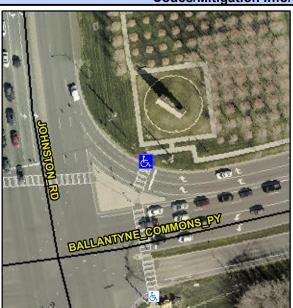
Comp	liance Description	Data	Comp	liance Description	Data
N/A	Ramp Length (in)	72.0	No	Ramp Slope (%)	9.4
Yes	Ramp Width (in)	59.0	Yes	Ramp XSlope (%)	1.8
N/A	Flare Type LT	N/A	N/A	Flare Type RT	N/A
N/A	Flare Slope LT (%)	N/A	N/A	Flare Slope RT (%)	N/A
N/A	Flare Traversable LT?	N/A	N/A	Flare Traversable RT?	N/A
N/A	Landing Length (in)	N/A	N/A	DWS Provided?	N/A
N/A	Landing Width (in)	N/A	N/A	DWS Contrast?	N/A
N/A	Landing Slope (%)	N/A	N/A	DWS Length (in)	N/A
N/A	Landing X Slope (%)	N/A	N/A	DWS Full Width?	N/A
N/A	Landing Curb? (Y/N)	N/A	N/A	DWS Offset (in)	N/A
N/A	Shared Landing?	N/A			
N/A	Gutter Ponding?	N/A	N/A	Gutter Slope (%)	N/A
N/A	Gutter Lip Ht (in)	N/A	N/A	Gutter X Slope (%)	N/A
N/A	Painted X Walk1?	Yes	N/A	Painted X Walk2?	N/A
	X Walk 1 Direction	To SW		X Walk 2 Direction	N/A
N/A	X Walk 1 Width (in)	120.0	N/A	X Walk 2 Width (in)	N/A
	X Walk 1 Slope (%)	1.7		X Walk 2 Slope (%)	N/A
	X Walk 1 X Slope (%)	1.8		X Walk 2 X Slope (%)	N/A

Possible Solution	
Possible Solutions:	9
Remove & Replace Entire Ramp.	
	١
	N
	N
	N
	1
Surveyor Notes:	1
N/A	1
	1
	1
	1
PROW/ADA:	1
R304.2.2	N
	N
	N
