Access Compliance Report

Public Rights-of-Way

| Intersection ID: 53633 | Main Street: TREMONT_RIDGE_CT | Cross Street: BEACON_VALLEY_ST | Location: NW |
| ADA ID: DC3A503A1998 | Ramp Type: Perp | Initial Pass/Fail: Fail | Overall Compliance: No |

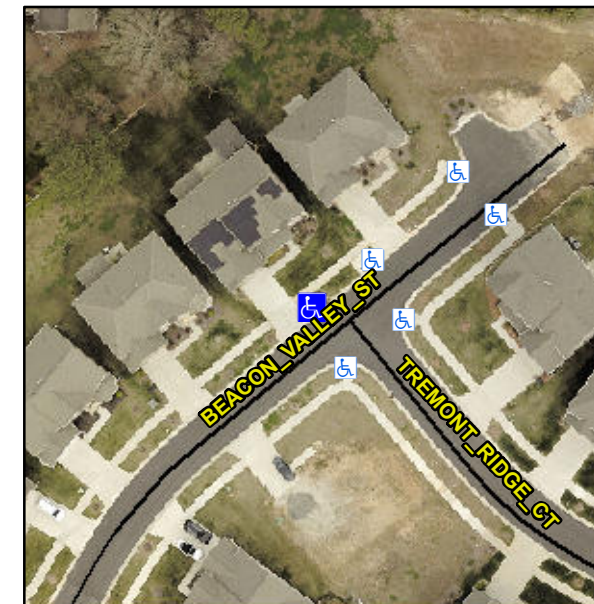
Not Found, R304.5.3

| Compliance | Description | Data | Compliance | Description | Data |
|---|---|---|---|---|---|
| Yes | Ramp Width (in) | 48.0 | No | Ramp XSlope (%) | 9.6 |

Remove & Replace Entire Ramp.

Total Cost: \$ 1850.00
