# Access Compliance Report

## Public Rights-of-Way

### (Curb Ramps)

| Intersection ID: 2675 | Main Street: HEATHCREST_CT | Cross Street: MCCHESENEY_DR | Location: | S |

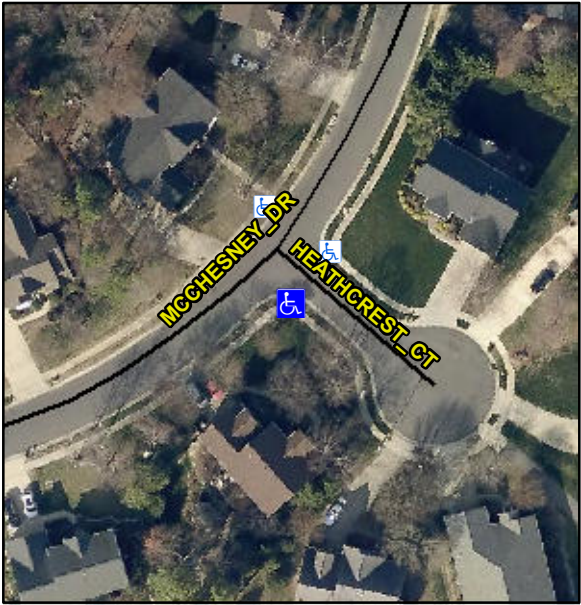
| ADA ID: DC3E42B452F7 | Ramp Type: Perp | Initial Pass/Fail: Fail | Overall Compliance: No | Severity Score: 12.5 |

| Codes/Mitigation Info/Possible Solution | | | Field Measurements/Component Compliance | | |
|---|--|---|---|---|---|
| | | | <b>No</b> | Ramp Width (in) | 48.0 |
| <p>Surveyor Notes:</p> <p><b>N/A</b></p> <p>PROW/ADA:</p> <p><b>Not Found, R304.5.3</b></p> | | | <b>N/A</b> | Flare Type RT | N/A |

| Codes/Mitigation Info/Possible Solution | | | Field Measurements/Component Compliance | | |
|---|--|---|---|---|---|
| | <b>Remove &amp; Replace Entire Ramp.</b> | | <b>Yes</b> | Ramp Length (in) | 52.0 |
