Access Compliance Report

Public Rights-of-Way (Curb Ramps)

| Intersection ID: 24195 | Main Street: PROVIDENCE_RD | Cross Street: BEVERLY_CREST_BV | Location: SE |
| ADA ID: DC443F0412D9 | Ramp Type: Perp | Initial Pass/Fail: Fail | Overall Compliance: No |

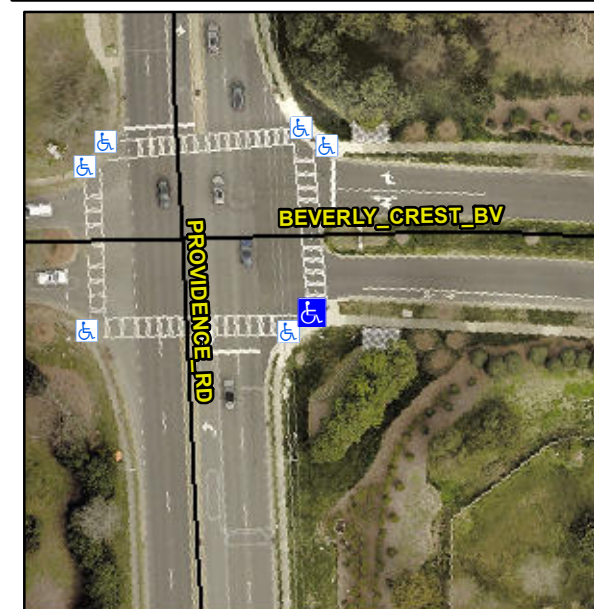
| Severity Score: 21.25 | | | |

R304.5.1, R304.5.3

| Compliance | Description | Data | Compliance | Description | Data |
|---|---|---|---|---|---|
| N/A | Ramp Length (in) | 50.0 | Yes | Ramp Slope (%) | 6.3 |
| No | Ramp Width (in) | 46.0 | No | Ramp XSlope (%) | 6.0 |

Possible Solutions:

Remove & Replace Entire Ramp.

Total Cost: \$ 1850.00
