Access Compliance Report

Public Rights-of-Way

(Curb Ramps)

| Intersection ID: N/A | Main Street: POPLAR FOREST DR | Cross Street: N/A | Location: NW |

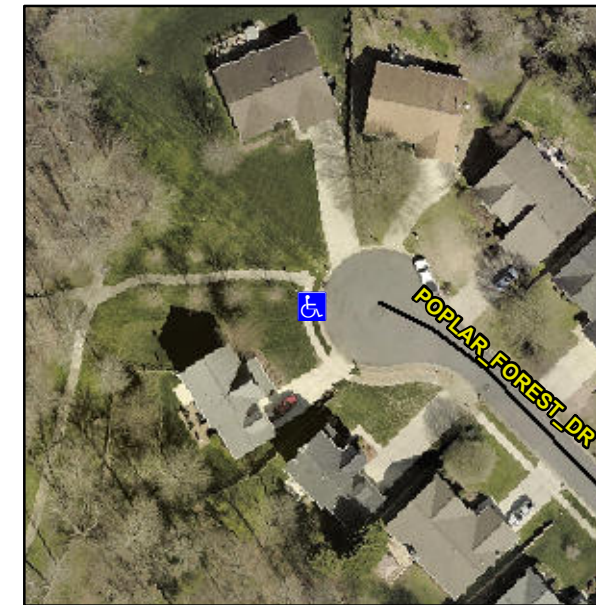
| ADA ID: DC49BBC53122 | Ramp Type: Perp | Initial Pass/Fail: Fail | Overall Compliance: No |
| | | Severity Score: 25 | |

Not Found, R304.2.2, R304.5.3

| Compliance | Description | Data | Compliance | Description | Data |
|---|---|---|---|---|---|
| N/A | Ramp Length (in) | 92.0 | No | Ramp Slope (%) | 10.5 |
| Yes | Ramp Width (in) | 109.0 | No | Ramp XSlope (%) | 6.1 |

Possible Solutions:

Remove & Replace Entire Ramp.

Total Cost: \$ 1850.00
