# Access Compliance Report

## Public Rights-of-Way

### (Curb Ramps)

Intersection ID: 24549	Main Street: I-485_RA	Cross Street: SOUTH_BV	Location: E
ADA ID: DC4FD6E4AEF4	Ramp Type: BlendTrans1	Initial Pass/Fail: Fail	Overall Compliance: No
Severity Score: 12.5			
Codes/Mitigation Info/Possible Solution		Field Measurements/Component Compliance

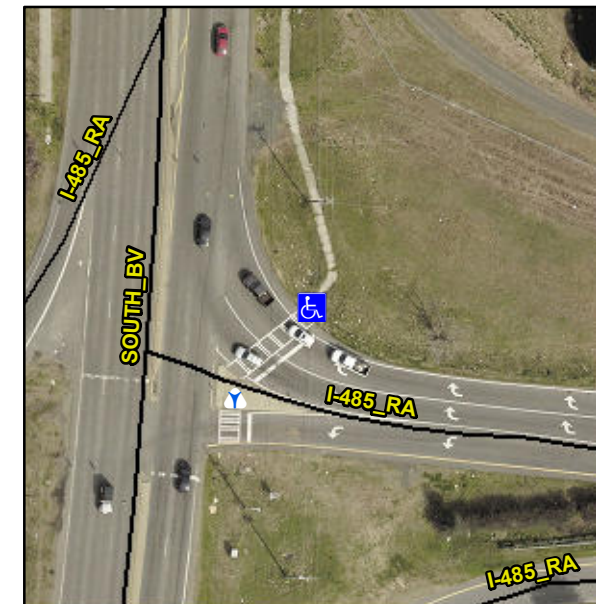
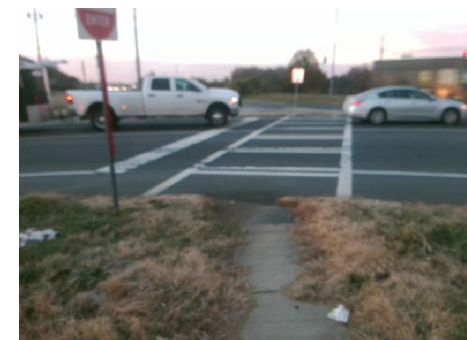
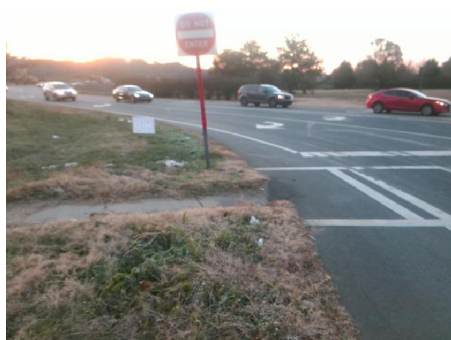
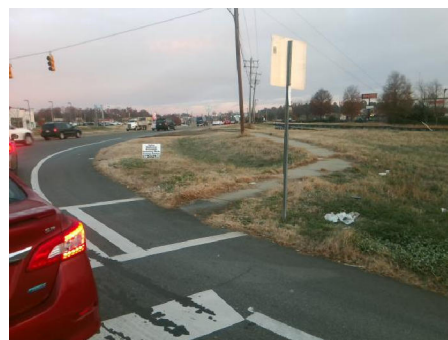
**Not Found, R304.5.3**

Compliance	Description	Data	Compliance	Description	Data
N/A	Ramp Length (in)	40.0	Yes	BlendTrans Slope (%)	1.3
Yes	Ramp Width (in)	60.0	No	BlendTrans XSlope (%)	5.6
N/A	Flare Type LT	N/A	N/A	Flare Type RT	N/A
N/A	Flare Slope LT (%)	N/A	N/A	Flare Slope RT (%)	N/A
N/A	Flare Traversable LT?	N/A	N/A	Flare Traversable RT?	N/A
N/A	Landing Length (in)	N/A	N/A	DWS Provided?	N/A
N/A	Landing Width (in)	N/A	N/A	DWS Contrast?	N/A
N/A	Landing Slope (%)	N/A	N/A	DWS Length (in)	N/A
N/A	Landing X Slope (%)	N/A	N/A	DWS Full Width?	N/A
N/A	Landing Curb? (Y/N)	N/A	N/A	DWS Offset (in)	N/A
N/A	Shared Landing?	N/A			
N/A	Gutter Ponding?	N/A	N/A	Gutter Slope (%)	N/A
N/A	Gutter Lip Ht (in)	N/A	N/A	Gutter X Slope (%)	N/A
N/A	Painted X Walk1?	Yes	N/A	Painted X Walk2?	N/A
	X Walk 1 Direction	To SW		X Walk 2 Direction	N/A
	X Walk 1 Width (in)	110.0		X Walk 2 Width (in)	N/A
	X Walk 1 Slope (%)	3.4		X Walk 2 Slope (%)	N/A
	X Walk 1 X Slope (%)	3.0		X Walk 2 X Slope (%)	N/A

N/A	Ramp inside XWalk1?	Yes	N/A	Ramp inside XWalk2?	N/A
	Road Slope (%)	3.0		Clear Space?	N/A
	Road X Slope (%)	3.4	N/A	Clear Space to XWalk (in)	N/A
N/A	Any Obstructions?	N/A	N/A	Storm Grate/Utility Hazard?	N/A
	Obstruction Type			Storm Grate/Utility Type	
		N/A			N/A
			Yes	Surface Condition? (G/P)	Good
			No	Curb Slope (%)	8.4

**Remove & Replace Curb Ramp With Two New Directional Ramps or Equivalent.**
