## Access Compliance Report Public Rights-of-Way (Curb Ramps)

Intersection ID: N/AMain Street:PINEVILLE-MATTHEWS\_RDCross Street: N/ALocation:SEADA ID: DC52BB961D92Ramp Type:PerpDiagInitial Pass/Fail: FailOverall Compliance: NoSeverity Score:10

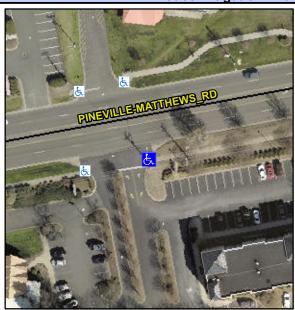
Fleid Measurements/Component Compilance								
	Compliance Description		Data	Compliance Description		Data		
	N/A	Ramp Length (in)	42.5	Yes	Ramp Slope (%)	6.7		
	No	Ramp Width (in)	44.0	Yes	Ramp XSlope (%)	2.3		
	N/A	Flare Type LT	N/A	N/A	Flare Type RT	N/A		
	N/A	Flare Slope LT (%)	N/A	N/A	Flare Slope RT (%)	N/A		
	N/A	Flare Traversable LT?	N/A	N/A	Flare Traversable RT?	N/A		
	N/A	Landing Length (in)	N/A	N/A	DWS Provided?	N/A		
	N/A	Landing Width (in)	N/A	N/A	DWS Contrast?	N/A		
	N/A	Landing Slope (%)	N/A	N/A	DWS Length (in)	N/A		
	N/A	Landing X Slope (%)	N/A	N/A	DWS Full Width?	N/A		
	N/A	Landing Curb? (Y/N)	N/A	N/A	DWS Offset (in)	N/A		
	N/A	Shared Landing?	N/A					
	N/A	Gutter Ponding?	N/A	N/A	Gutter Slope (%)	N/A		
	N/A	Gutter Lip Ht (in)	N/A	N/A	Gutter X Slope (%)	N/A		
	N/A	Painted X Walk1?	No	N/A	Painted X Walk2?	No		
		X Walk 1 Direction	To N		X Walk 2 Direction	To W		
	N/A	X Walk 1 Width (in)	N/A	N/A	X Walk 2 Width (in)	N/A

X Walk 1 Slope (%)	3.0		X Walk 2 Slope (%)	1.6		
		X Walk 1 X Slope (%)	2.4		X Walk 2 X Slope (%)	3.1		
	N/A	Ramp inside XWalk1?	N/A	N/A	Ramp inside XWalk2?	N/A		
		Road Slope (%)	3.1	N/A	Clear Space?	N/A		
		Road X Slope (%)	0.3	N/A	Clear Space to XWalk (in)	N/A		
	N/A	Any Obstructions?	N/A	N/A	Storm Grate/Utility Hazard?	N/A		
		Obstruction Type			Storm Grate/Utility Type			
			N/A			N/A		
				Yes	Surface Condition? (G/P)	Good

Possible Solution					
Possible Solutions:	<u>c</u>				
Remove & Replace Curb Ramp With					
Two New Directional Ramps or					
Equivalent.					
	N				
	N.				
	N				
Surveyor Notes:	N				
N/A	N				
	N				
	N				
	N.				
PROW/ADA:	N				
Not Found, R304.5.1	N.				
	N.				
	N

Total Cost: \$ 3200.00
