Access Compliance Report

Public Rights-of-Way

(Curb Ramps)

Intersection ID: 14505	Main Street: REMOUNT_RD	Cross Street: REMUS_RD	Location: NE
ADA ID: DC5A12BDE818	Ramp Type: PerpDiag	Initial Pass/Fail: Fail	Overall Compliance: No
		Severity Score: 72.5

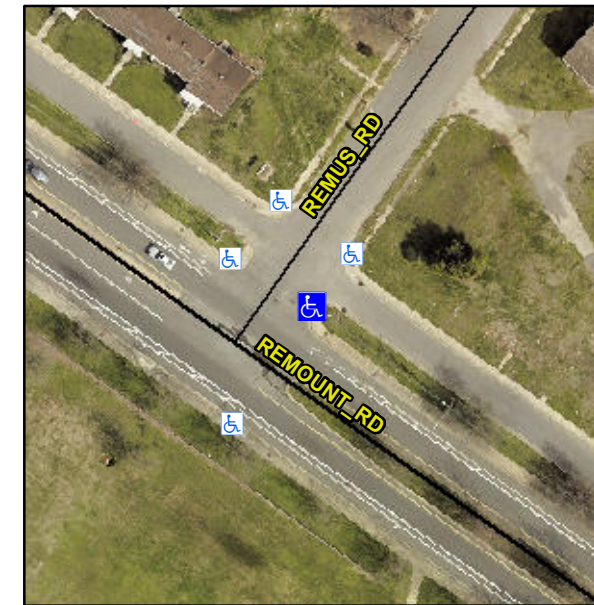
Not Found, R304.5.1, R304.2.2, R304.5.3

Compliance	Description	Data	Compliance	Description	Data
N/A	Ramp Length (in)	59.0	No	Ramp Slope (%)	10.6
No	Ramp Width (in)	25.0	No	Ramp XSlope (%)	9.1
N/A	Flare Type LT	N/A	N/A	Flare Type RT	N/A
N/A	Flare Slope LT (%)	N/A	N/A	Flare Slope RT (%)	N/A
N/A	Flare Traversable LT?	N/A	N/A	Flare Traversable RT?	N/A
N/A	Landing Length (in)	N/A	N/A	DWS Provided?	N/A
N/A	Landing Width (in)	N/A	N/A	DWS Contrast?	N/A
N/A	Landing Slope (%)	N/A	N/A	DWS Length (in)	N/A
N/A	Landing X Slope (%)	N/A	N/A	DWS Full Width?	N/A
N/A	Landing Curb? (Y/N)	N/A	N/A	DWS Offset (in)	N/A
N/A	Shared Landing?	N/A			
N/A	Gutter Ponding?	N/A	N/A	Gutter Slope (%)	N/A
N/A	Gutter Lip Ht (in)	N/A	N/A	Gutter X Slope (%)	N/A
N/A	Painted X Walk1?	No	N/A	Painted X Walk2?	No
	X Walk 1 Direction	To NE		X Walk 2 Direction	To NW
N/A	X Walk 1 Width (in)	N/A	N/A	X Walk 2 Width (in)	N/A
	X Walk 1 Slope (%)	6.7		X Walk 2 Slope (%)	4.9
	X Walk 1 X Slope (%)	4.5		X Walk 2 X Slope (%)	2.0

N/A	Ramp inside XWalk1?	N/A	N/A	Ramp inside XWalk2?	N/A
	Road Slope (%)	6.0	N/A	Clear Space?	N/A
	Road X Slope (%)	2.8	N/A	Clear Space to XWalk (in)	N/A
N/A	Any Obstructions?	N/A	N/A	Storm Grate/Utility Hazard?	N/A
	Obstruction Type			Storm Grate/Utility Type	
		N/A			N/A
			Yes	Surface Condition? (G/P)	Good

Remove & Replace Curb Ramp With Two New Directional Ramps or Equivalent.
