Access Compliance Report

Public Rights-of-Way

(Curb Ramps)

| Intersection ID: 14086 | Main Street: BALDWIN_AV | Cross Street: E_3RD_ST | Location: W |

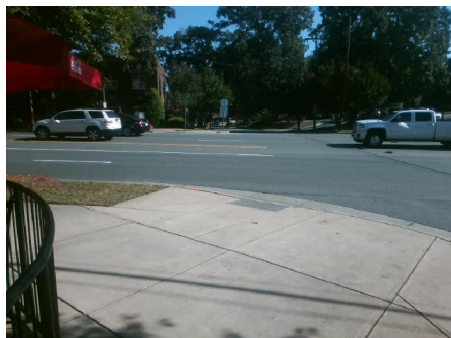
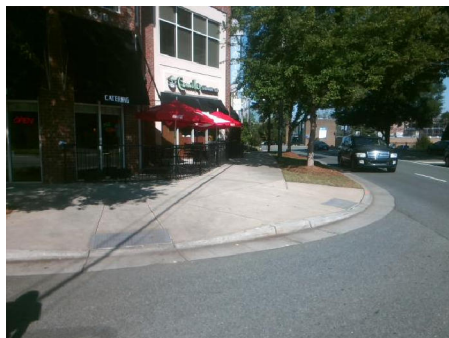
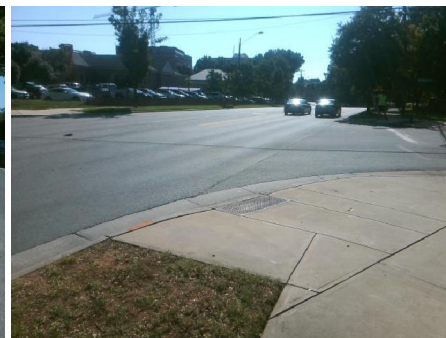
R304.5.1, R304.2.2, R304.5.3

| Compliance | Description | Data | Compliance | Description | Data |
|---|---|---|---|---|---|
| N/A | Ramp Length (in) | 117.0 | No | Ramp Slope (%) | 8.6 |
| No | Ramp Width (in) | 35.0 | No | Ramp XSlope (%) | 3.8 |

Remove & Replace Entire Ramp.

Total Cost: \$ **1850.00**
