## Access Compliance Report Public Rights-of-Way (Curb Ramps)

• 		-					
Intersection ID: 46769	769 Main Street: MCALLISTER_DR			treet:	COLEMON_KERRY_D	Location:	SW		
ADA ID: DC62DDED6674	A ID: DC62DDED6674 Ramp Type: PerpDiag			Initial Pass/Fail: Fail Overall Compliance: No				o Severity Score:	46.25
Codes/Mitigation Info/Possible Solution				Field Measurements/Component Compliance					
Possible Solutions:				Compliance Description Data Compliance					Data
	<u>E</u>	Remove & Replace Curb Ramp Wit Two New Directional Ramps or Equivalent.	/ith	N/A	Ramp Length (in)	73.5	No	Ramp Slope (%)	10.6
				No	Ramp Width (in)	38.5	No	Ramp XSlope (%)	8.1
				N/A	Flare Type LT	N/A	N/A	Flare Type RT	N/A
				N/A	Flare Slope LT (%)	N/A	N/A	Flare Slope RT (%)	N/A
and the second second				N/A	Flare Traversable LT?	N/A	N/A	Flare Traversable RT?	N/A
MCALLIEU	IR DR			N/A	Landing Length (in)	N/A	N/A	DWS Provided?	N/A
MOAUSCO	L &			N/A	Landing Width (in)	N/A	N/A	DWS Contrast?	N/A
the loss of the loss of the		N/A		N/A	Landing Slope (%)	N/A	N/A	DWS Length (in)	N/A

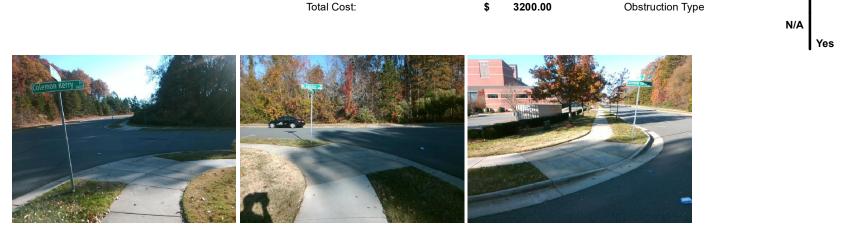
N/A		N/A	Landing X Slope (%)	N/A	N/A	DWS Full Width?	N/A
				N/A	Landing Curb? (Y/N)	N/A	N/A	DWS Offset (in)	N/A
A A A A A A A A A A A A A A A A A A A		PROW/ADA:		N/A	Shared Landing?	N/A			
1 de 1				N/A	Gutter Ponding?	N/A	N/A	Gutter Slope (%)	N/A
				N/A	Gutter Lip Ht (in)	N/A	N/A	Gutter X Slope (%)	N/A
	E Bank	Not Found, R304.5.1, R304.2.2, R304.5.3		N/A	Painted X Walk1?	No	N/A	Painted X Walk2?	N/A No
2		1004.0.0		11/1	X Walk 1 Direction	To E	10/2	X Walk 2 Direction	To N
				N/A	X Walk 1 Width (in)	N/A	N/A	X Walk 2 Width (in)	N/A
				N/A			N/A		
Street 1 Name	COLEMON KERRY DR				X Walk 1 Slope (%)	0.2		X Walk 2 Slope (%)	2.6
Stop Condition-Street 2	StopSign				X Walk 1 X Slope (%)	3.5		X Walk 2 X Slope (%)	5.0
Street 2 Name	MCALLISTER DR			N/A	Ramp inside XWalk1?	N/A	N/A	Ramp inside XWalk2?	N/A
Stop Condition-Street 1	None				Road Slope (%)	4.5	N/A	Clear Space?	N/A
					Road X Slope (%)	2.9	N/A	Clear Space to XWalk (in)	N/A

es Surface Condition? (G/P)

Good

N/A	Any Obstructions?	N/A	N/A	Storm Grate/Utility Hazard?	N/A
		Total Cost: \$ 32	200.00		Obstruction Type			Storm Grate/Utility Type	
						N/A			N/A
