Access Compliance Report

Public Rights-of-Way

(Curb Ramps)

Intersection ID: 28270	Main Street: PEMSWOOD_ST	Cross Street: SUMMER CLUB_RD	Location: NW
ADA ID: DC79E2E80B90	Ramp Type: Perp	Initial Pass/Fail: Fail	Overall Compliance: No
Severity Score: 25			
Codes/Mitigation Info/Possible Solution		Field Measurements/Component Compliance

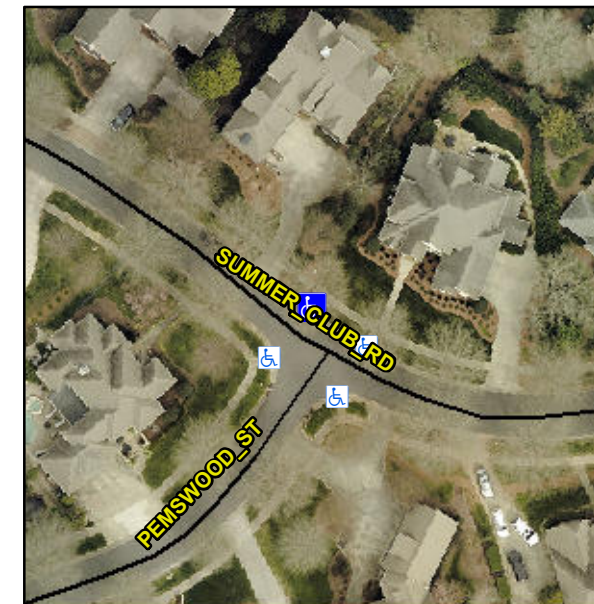
R304.2.2, R304.5.3

Compliance	Description	Data	Compliance	Description	Data
N/A	Ramp Length (in)	93.0	No	Ramp Slope (%)	9.8
Yes	Ramp Width (in)	53.0	No	Ramp XSlope (%)	5.5
N/A	Flare Type LT	N/A	N/A	Flare Type RT	N/A
N/A	Flare Slope LT (%)	N/A	N/A	Flare Slope RT (%)	N/A
N/A	Flare Traversable LT?	N/A	N/A	Flare Traversable RT?	N/A
N/A	Landing Length (in)	N/A	N/A	DWS Provided?	N/A
N/A	Landing Width (in)	N/A	N/A	DWS Contrast?	N/A
N/A	Landing Slope (%)	N/A	N/A	DWS Length (in)	N/A
N/A	Landing X Slope (%)	N/A	N/A	DWS Full Width?	N/A
N/A	Landing Curb? (Y/N)	N/A	N/A	DWS Offset (in)	N/A
N/A	Shared Landing?	N/A			
N/A	Gutter Ponding?	N/A	N/A	Gutter Slope (%)	N/A
N/A	Gutter Lip Ht (in)	N/A	N/A	Gutter X Slope (%)	N/A
N/A	Painted X Walk1?	No	N/A	Painted X Walk2?	N/A
	X Walk 1 Direction	To SW		X Walk 2 Direction	N/A
N/A	X Walk 1 Width (in)	N/A	N/A	X Walk 2 Width (in)	N/A
	X Walk 1 Slope (%)	0.8		X Walk 2 Slope (%)	N/A
	X Walk 1 X Slope (%)	1.2		X Walk 2 X Slope (%)	N/A

N/A	Ramp inside XWalk1?	N/A	N/A	Ramp inside XWalk2?	N/A
	Road Slope (%)	N/A	N/A	Clear Space?	N/A
	Road X Slope (%)	N/A	N/A	Clear Space to XWalk (in)	N/A
N/A	Any Obstructions?	N/A	N/A	Storm Grate/Utility Hazard?	N/A
	Obstruction Type			Storm Grate/Utility Type	
		N/A			N/A
			Yes	Surface Condition? (G/P)	Good

Remove & Replace Entire Ramp.
