Access Compliance Report

Public Rights-of-Way

(Curb Ramps)

Intersection ID: 42985	Main Street: BESSANT_CT	Cross Street: CHOWNING_TAVERN_LN	Location: N
ADA ID: DC7A3B8A782F	Ramp Type: PerpDiag	Initial Pass/Fail: Fail	Overall Compliance: No
		Severity Score: 46.25

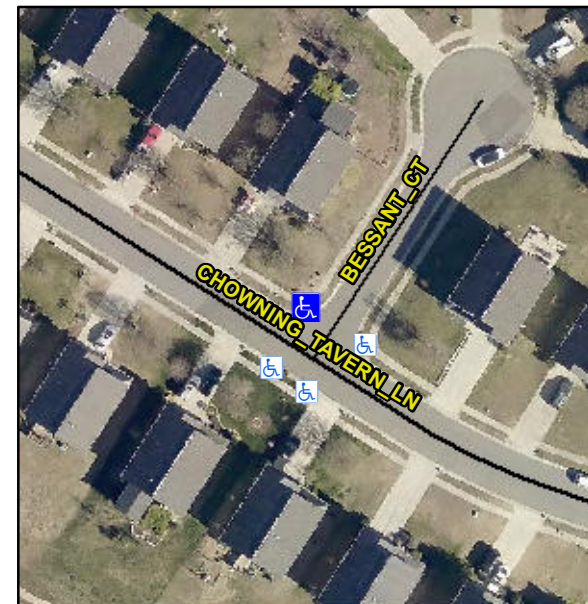
Not Found, R304.5.1, R304.2.2, R304.5.3

Compliance	Description	Data	Compliance	Description	Data
N/A	Ramp Length (in)	48.0	No	Ramp Slope (%)	10.5
No	Ramp Width (in)	43.0	No	Ramp XSlope (%)	9.1
N/A	Flare Type LT	N/A	N/A	Flare Type RT	N/A
N/A	Flare Slope LT (%)	N/A	N/A	Flare Slope RT (%)	N/A
N/A	Flare Traversable LT?	N/A	N/A	Flare Traversable RT?	N/A
N/A	Landing Length (in)	N/A	N/A	DWS Provided?	N/A
N/A	Landing Width (in)	N/A	N/A	DWS Contrast?	N/A
N/A	Landing Slope (%)	N/A	N/A	DWS Length (in)	N/A
N/A	Landing X Slope (%)	N/A	N/A	DWS Full Width?	N/A
N/A	Landing Curb? (Y/N)	N/A	N/A	DWS Offset (in)	N/A
N/A	Shared Landing?	N/A			
N/A	Gutter Ponding?	N/A	N/A	Gutter Slope (%)	N/A
N/A	Gutter Lip Ht (in)	N/A	N/A	Gutter X Slope (%)	N/A
N/A	Painted X Walk1?	No	N/A	Painted X Walk2?	No
	X Walk 1 Direction	To SW		X Walk 2 Direction	To SE
N/A	X Walk 1 Width (in)	N/A	N/A	X Walk 2 Width (in)	N/A
	X Walk 1 Slope (%)	3.3		X Walk 2 Slope (%)	2.4
	X Walk 1 X Slope (%)	3.4		X Walk 2 X Slope (%)	6.4

N/A	Ramp inside XWalk1?	N/A	N/A	Ramp inside XWalk2?	N/A
	Road Slope (%)	5.7	N/A	Clear Space?	N/A
	Road X Slope (%)	0.3	N/A	Clear Space to XWalk (in)	N/A
N/A	Any Obstructions?	N/A	N/A	Storm Grate/Utility Hazard?	N/A
	Obstruction Type			Storm Grate/Utility Type	
		N/A			N/A
			Yes	Surface Condition? (G/P)	Good

Remove & Replace Curb Ramp With Two New Directional Ramps or Equivalent.
