Access Compliance Report Public Rights-of-Way (Curb Ramps)

Intersection ID: 18083Main Street:DELLWOOD_AVCross Street: HILLSDALE_AVLocation:SWADA ID: DC7C1D47ED7ARamp Type:PerpInitial Pass/Fail:FailOverall Compliance: NoSeverity Score:37.5

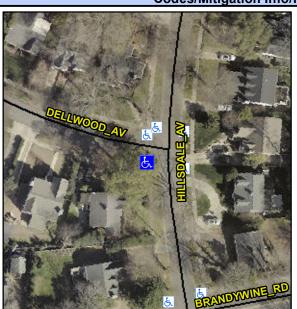
Field Measurements/Component Compliance								
Compliance Description		Data	Compliance		Description	Data		
N/A	Ramp Length (in)	51.0	No	Ramp	Slope (%)	10.7		
Yes	Ramp Width (in)	55.5	No	Ramp	XSlope (%)	7.0		
N/A	Flare Type LT	N/A	N/A	Flare	Type RT	N/A		
N/A	Flare Slope LT (%)	N/A	N/A	Flare	Slope RT (%)	N/A		
N/A	Flare Traversable LT?	N/A	N/A	Flare	Traversable RT?	N/A		
N/A	Landing Length (in)	N/A	N/A	DWS	Provided?	N/A		
N/A	Landing Width (in)	N/A	N/A	DWS	Contrast?	N/A		
N/A	Landing Slope (%)	N/A	N/A	DWS	Length (in)	N/A		
N/A	Landing X Slope (%)	N/A	N/A	DWS	Full Width?	N/A		
N/A	Landing Curb? (Y/N)	N/A	N/A	DWS	Offset (in)	N/A		
N/A	Shared Landing?	N/A						
N/A	Gutter Ponding?	N/A	N/A	Gutte	r Slope (%)	N/A		
N/A	Gutter Lip Ht (in)	N/A	N/A	Gutte	r X Slope (%)	N/A		
N/A	Painted X Walk1?	No	N/A	Paint	ed X Walk2?	N/A		
	X Walk 1 Direction	To N		X Wa	lk 2 Direction	N/A		
N/A	X Walk 1 Width (in)	N/A	N/A	X Wa	lk 2 Width (in)	N/A

X Walk 1 Slope (%)	0.8		X Wa	lk 2 Slope (%)	N/A		
	X Walk 1 X Slope (%)	5.4		X Wa	lk 2 X Slope (%)	N/A		
N/A	Ramp inside XWalk1?	N/A	N/A	Ram	inside XWalk2?	N/A		
	Road Slope (%)	N/A	N/A	Clear	Space?	N/A		
	Road X Slope (%)	N/A	N/A	Clear	Space to XWalk (in)	N/A		
N/A	Any Obstructions?	N/A	N/A	Storn	n Grate/Utility Hazard?	N/A		
	Obstruction Type			Storn	n Grate/Utility Type			
		N/A				N/A		
			Yes	Surfa	ce Condition? (G/P)	Good

Possible Solutions:	9
Remove & Replace Entire Ramp.	N
	Y
	N
	N
	N
	N
Surveyor Notes:	N
N/A	N
	N
	N
	N
PROW/ADA:	N
Not Found, R304.2.2, R304.5.3	N
	N
	N
	N

1850.00
