Access Compliance Report

Public Rights-of-Way

(Curb Ramps)

Intersection ID: 23124	Main Street: MOSS_RD	Cross Street: LAUREL_TRACE_DR	Location: SW
ADA ID: DC8B2F00C59F	Ramp Type: Perp	Initial Pass/Fail: Fail	Overall Compliance: No
Severity Score: 21.25			
Codes/Mitigation Info/Possible Solution		Field Measurements/Component Compliance

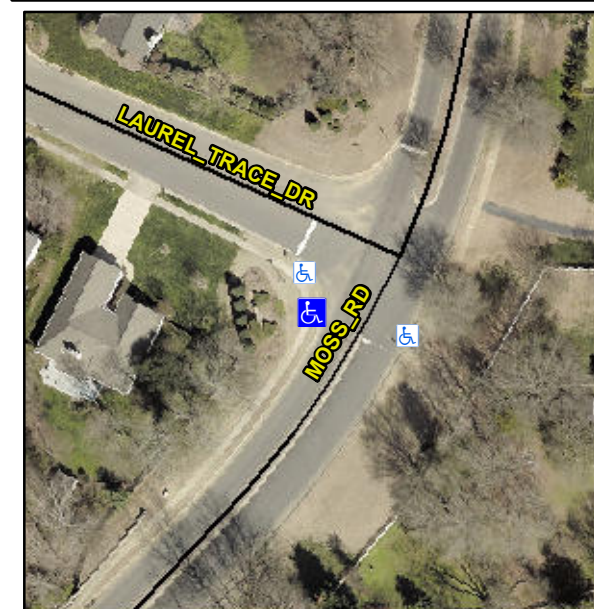
Not Found, R304.5.1, R304.2.2

Compliance	Description	Data	Compliance	Description	Data
N/A	Ramp Length (in)	45.0	No	Ramp Slope (%)	8.5
No	Ramp Width (in)	45.0	Yes	Ramp XSlope (%)	0.9
N/A	Flare Type LT	N/A	N/A	Flare Type RT	N/A
N/A	Flare Slope LT (%)	N/A	N/A	Flare Slope RT (%)	N/A
N/A	Flare Traversable LT?	N/A	N/A	Flare Traversable RT?	N/A
N/A	Landing Length (in)	N/A	N/A	DWS Provided?	N/A
N/A	Landing Width (in)	N/A	N/A	DWS Contrast?	N/A
N/A	Landing Slope (%)	N/A	N/A	DWS Length (in)	N/A
N/A	Landing X Slope (%)	N/A	N/A	DWS Full Width?	N/A
N/A	Landing Curb? (Y/N)	N/A	N/A	DWS Offset (in)	N/A
N/A	Shared Landing?	N/A			
N/A	Gutter Ponding?	N/A	N/A	Gutter Slope (%)	N/A
N/A	Gutter Lip Ht (in)	N/A	N/A	Gutter X Slope (%)	N/A
N/A	Painted X Walk1?	No	N/A	Painted X Walk2?	N/A
	X Walk 1 Direction	To SE		X Walk 2 Direction	N/A
N/A	X Walk 1 Width (in)	N/A	N/A	X Walk 2 Width (in)	N/A
	X Walk 1 Slope (%)	1.5		X Walk 2 Slope (%)	N/A
	X Walk 1 X Slope (%)	1.5		X Walk 2 X Slope (%)	N/A

N/A	Ramp inside XWalk1?	N/A	N/A	Ramp inside XWalk2?	N/A
	Road Slope (%)	N/A	N/A	Clear Space?	N/A
	Road X Slope (%)	N/A	N/A	Clear Space to XWalk (in)	N/A
N/A	Any Obstructions?	N/A	N/A	Storm Grate/Utility Hazard?	N/A
	Obstruction Type			Storm Grate/Utility Type	
		N/A			N/A
			Yes	Surface Condition? (G/P)	Good

Remove & Replace Entire Ramp.

Total Cost: \$ 1850.00
