Access Compliance Report

Public Rights-of-Way

(Curb Ramps)

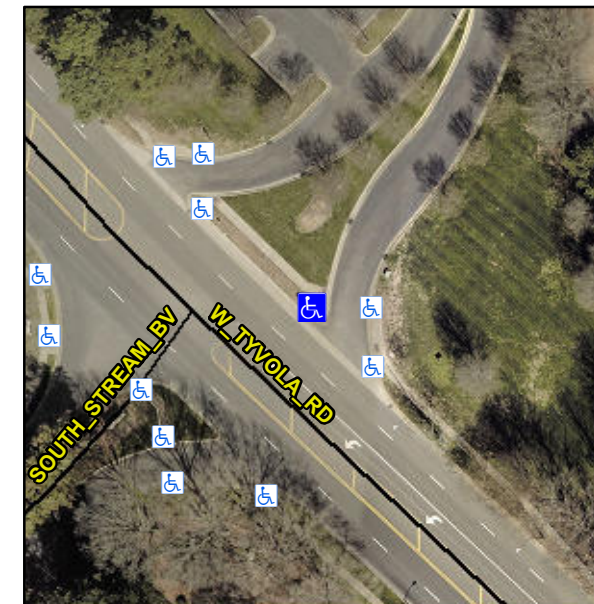
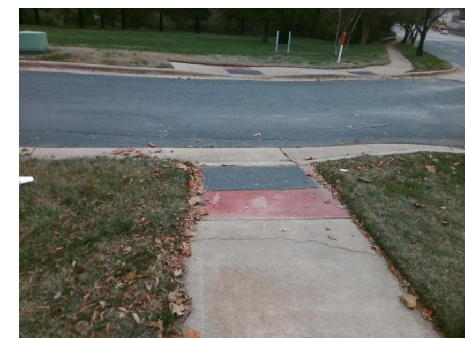
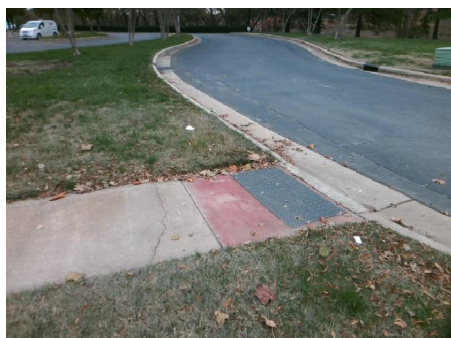
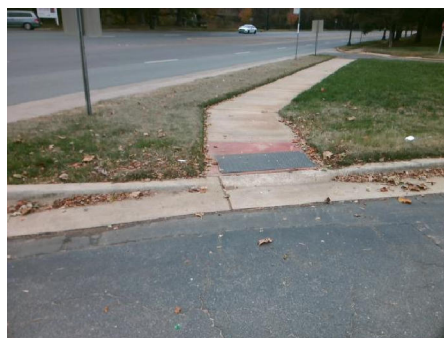
Intersection ID: N/A	Main Street: W_TYVOLA_RD	Cross Street: N/A	Location: NE
ADA ID: DC95EB78E0CF	Ramp Type: BlendTrans1	Initial Pass/Fail: Fail	Overall Compliance: No
Severity Score: 10			
Codes/Mitigation Info/Possible Solution		Field Measurements/Component Compliance

LOCATED ON ISLAND

R304.5.1, R304.5.3

Compliance	Description	Data	Compliance	Description	Data
N/A	Ramp Length (in)	49.0	Yes	BlendTrans Slope (%)	0.1
No	Ramp Width (in)	43.0	No	BlendTrans XSlope (%)	3.6
N/A	Flare Type LT	N/A	N/A	Flare Type RT	N/A
N/A	Flare Slope LT (%)	N/A	N/A	Flare Slope RT (%)	N/A
N/A	Flare Traversable LT?	No	N/A	Flare Traversable RT?	No
N/A	Landing Length (in)	N/A	N/A	DWS Provided?	N/A
N/A	Landing Width (in)	N/A	N/A	DWS Contrast?	N/A
N/A	Landing Slope (%)	N/A	N/A	DWS Length (in)	N/A
N/A	Landing X Slope (%)	N/A	N/A	DWS Full Width?	N/A
N/A	Landing Curb? (Y/N)	N/A	N/A	DWS Offset (in)	N/A
N/A	Shared Landing?	N/A			
N/A	Gutter Ponding?	N/A	N/A	Gutter Slope (%)	N/A
N/A	Gutter Lip Ht (in)	N/A	N/A	Gutter X Slope (%)	N/A
N/A	Painted X Walk1?	No	N/A	Painted X Walk2?	N/A
	X Walk 1 Direction	To SE		X Walk 2 Direction	N/A
	X Walk 1 Width (in)	N/A		X Walk 2 Width (in)	N/A
	X Walk 1 Slope (%)	1.1		X Walk 2 Slope (%)	N/A
	X Walk 1 X Slope (%)	3.2		X Walk 2 X Slope (%)	N/A

Remove & Replace Curb Ramp With Two New Directional Ramps or Equivalent.
