# Access Compliance Report

## Public Rights-of-Way

### (Curb Ramps)

Intersection ID: 13398	Main Street: CENTRAL_AV	Cross Street: ST_GEORGE_ST	Location: SW
ADA ID: DC992F351CF3	Ramp Type: Perp	Initial Pass/Fail: Fail	Overall Compliance: No
Severity Score: 21.25			
Codes/Mitigation Info/Possible Solution		Field Measurements/Component Compliance

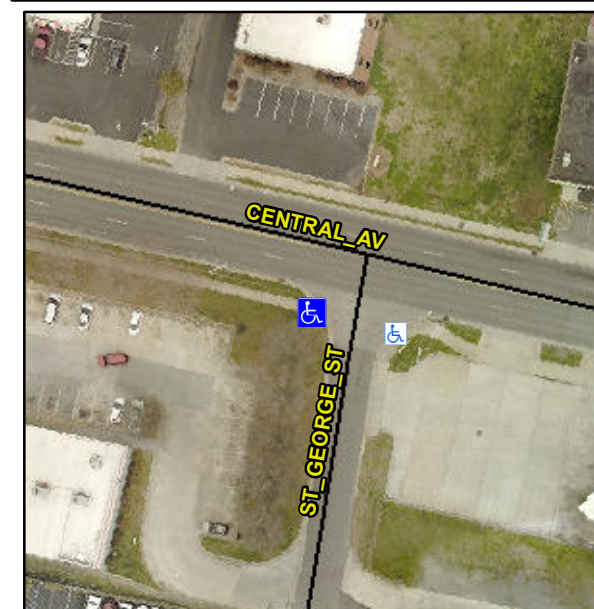
**Not Found, R304.5.1, R304.2.2**

Compliance	Description	Data	Compliance	Description	Data
N/A	Ramp Length (in)	48.0	No	Ramp Slope (%)	9.0
No	Ramp Width (in)	40.0	Yes	Ramp XSlope (%)	2.0
N/A	Flare Type LT	N/A	N/A	Flare Type RT	N/A
N/A	Flare Slope LT (%)	N/A	N/A	Flare Slope RT (%)	N/A
N/A	Flare Traversable LT?	N/A	N/A	Flare Traversable RT?	N/A
N/A	Landing Length (in)	N/A	N/A	DWS Provided?	N/A
N/A	Landing Width (in)	N/A	N/A	DWS Contrast?	N/A
N/A	Landing Slope (%)	N/A	N/A	DWS Length (in)	N/A
N/A	Landing X Slope (%)	N/A	N/A	DWS Full Width?	N/A
N/A	Landing Curb? (Y/N)	N/A	N/A	DWS Offset (in)	N/A
N/A	Shared Landing?	N/A			
N/A	Gutter Ponding?	N/A	N/A	Gutter Slope (%)	N/A
N/A	Gutter Lip Ht (in)	N/A	N/A	Gutter X Slope (%)	N/A
N/A	Painted X Walk1?	No	N/A	Painted X Walk2?	N/A
	X Walk 1 Direction	To SE		X Walk 2 Direction	N/A
N/A	X Walk 1 Width (in)	N/A	N/A	X Walk 2 Width (in)	N/A
	X Walk 1 Slope (%)	0.9		X Walk 2 Slope (%)	N/A
	X Walk 1 X Slope (%)	0.6		X Walk 2 X Slope (%)	N/A

N/A	Ramp inside XWalk1?	N/A	N/A	Ramp inside XWalk2?	N/A
	Road Slope (%)	N/A	N/A	Clear Space?	N/A
	Road X Slope (%)	N/A	N/A	Clear Space to XWalk (in)	N/A
N/A	Any Obstructions?	N/A	N/A	Storm Grate/Utility Hazard?	N/A
	Obstruction Type			Storm Grate/Utility Type	
		N/A			N/A
		Yes		Surface Condition? (G/P)	Good

**Remove & Replace Entire Ramp.**

Total Cost: \$ 1850.00
