Access Compliance Report Public Rights-of-Way (Curb Ramps)

Cross Street: N SHARON AMITY RD Location: Intersection ID: 14848 Main Street: CLEARMONT AV Ε **Overall Compliance: No** 12.5 ADA ID: DC9FB363C4D0 Ramp Type: Perp Initial Pass/Fail: Fail **Severity Score:**

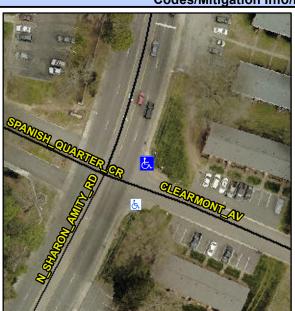
CLEARMONT AV Street 1 Name Stop Condition-Street 2 StopSign N/A Street 2 Name Stop Condition-Street 1 N/A Possible Solutions: Compliance Description N/A Remove & Replace Entire Ramp. Yes N/A N/A Surveyor Notes: N/A PROW/ADA: Not Found, R304.2.2
