# Access Compliance Report

## Public Rights-of-Way

| Intersection ID: N/A | Main Street: COUNTRY_WALK_DR | Cross Street: NATURE_WALK_DR | Location: E |
| ADA ID: DCA7400E7AE3 | Ramp Type: PerpDiag | Initial Pass/Fail: Fail | Overall Compliance: No |

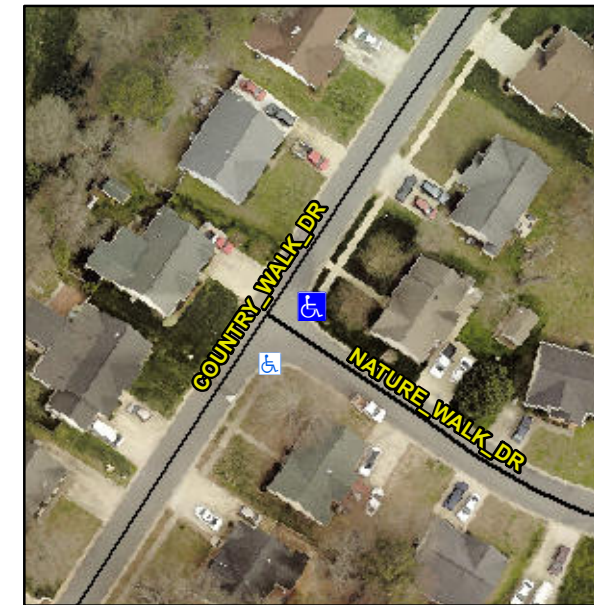
**Not Found, R304.5.1**

| Compliance | Description | Data | Compliance | Description | Data |
|---|---|---|---|---|---|
| N/A | Ramp Length (in) | 52.0 | Yes | Ramp Slope (%) | 7.6 |
| No | Ramp Width (in) | 40.0 | Yes | Ramp XSlope (%) | 2.8 |

**Remove & Replace Curb Ramp With Two New Directional Ramps or Equivalent.**
