| Intersection ID: 31472 | Main Street: ALSTON_HILL_DR | Cross Street: ARISTA_CT | Location: | NW |
| ADA ID: DCB3784E86AB | Ramp Type: PerpDiag | Initial Pass/Fail: Fail | Overall Compliance: No | Severity Score: 8.75 |

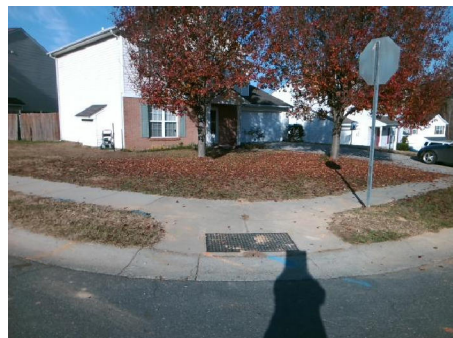
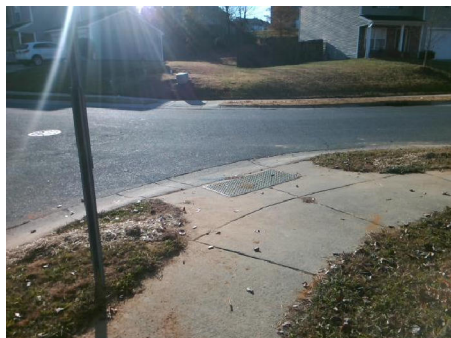
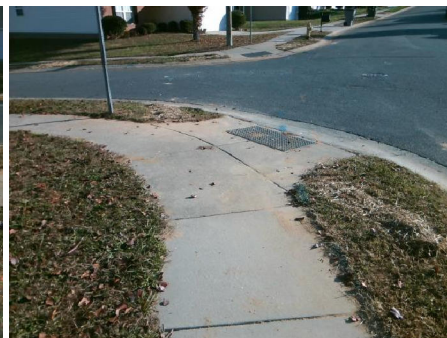
**Not Found, R304.5.1**

| Compliance | Description | Data | Compliance | Description | Data |
|---|---|---|---|---|---|
| No | Ramp Width (in) | 47.5 | Yes | Ramp XSlope (%) | 2.0 |

**Remove & Replace Curb Ramp With Two New Directional Ramps or Equivalent.**
