Intersection ID: 9255	Main Street: BOOKER_AV	Cross Street: CAMPUS_ST	Location:	SE
ADA ID: DCB6E094AFFF	Ramp Type: PerpDiag	Initial Pass/Fail: Fail	Overall Compliance: No	Severity Score: 17.5

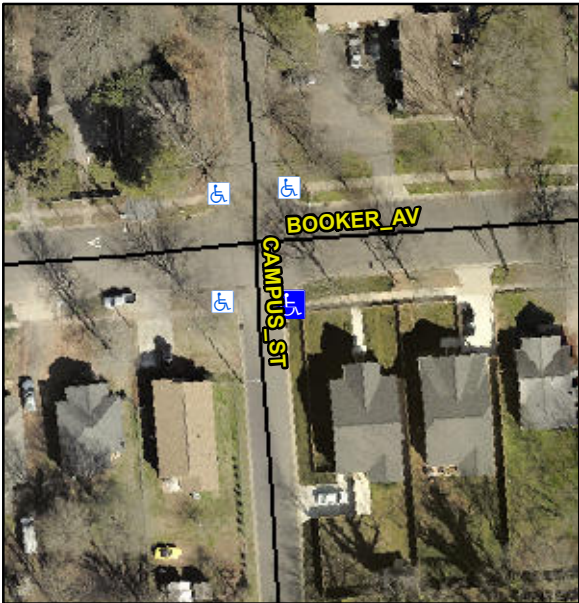
Possible Solutions:		Compliance	Description	Data	Compliance	Description	Data
	Remove & Replace Curb Ramp With Two New Directional Ramps or Equivalent.		N/A	Ramp Length (in)	60.0	Yes	Ramp Slope (%)	5.3
			No	Ramp Width (in)	32.0	Yes	Ramp XSlope (%)	0.2
			N/A	Flare Type LT	N/A	N/A	Flare Type RT	N/A
			N/A	Flare Slope LT (%)	N/A	N/A	Flare Slope RT (%)	N/A
			N/A	Flare Traversable LT?	N/A	N/A	Flare Traversable RT?	N/A
			N/A	Landing Length (in)	N/A	N/A	DWS Provided?	N/A
			N/A	Landing Width (in)	N/A	N/A	DWS Contrast?	N/A
			N/A	Landing Slope (%)	N/A	N/A	DWS Length (in)	N/A
			N/A	Landing X Slope (%)	N/A	N/A	DWS Full Width?	N/A
Street 1 Name	Surveyor Notes:		N/A	Landing Curb? (Y/N)	N/A	N/A	DWS Offset (in)	N/A
	N/A		N/A	Shared Landing?	N/A			
	PROW/ADA:		N/A	Gutter Ponding?	N/A	N/A	Gutter Slope (%)	N/A
	Not Found, R304.5.1		N/A	Gutter Lip Ht (in)	N/A	N/A	Gutter X Slope (%)	N/A

N/A	Painted X Walk1?	No	N/A	Painted X Walk2?	No
				X Walk 1 Direction	To N		X Walk 2 Direction	To W
			N/A	X Walk 1 Width (in)	N/A	N/A	X Walk 2 Width (in)	N/A
				X Walk 1 Slope (%)	4.0		X Walk 2 Slope (%)	2.2
				X Walk 1 X Slope (%)	1.9		X Walk 2 X Slope (%)	2.9
			N/A	Ramp inside XWalk1?	N/A	N/A	Ramp inside XWalk2?	N/A
Stop Condition-Street 2				Road Slope (%)	1.0	N/A	Clear Space?	N/A
				Road X Slope (%)	2.4	N/A	Clear Space to XWalk (in)	N/A
			N/A	Any Obstructions?	N/A	N/A	Storm Grate/Utility Hazard?	N/A
				Obstruction Type			Storm Grate/Utility Type	
					N/A			N/A
						Yes	Surface Condition? (G/P)	Good
Total Cost:		\$ 3200.00
